ANSWERS TO SUBMITTED QUESTIONS (2nd ROUND)

Subject: Earthquake-related geological hazards screening evaluation, Lake County courthouse sites

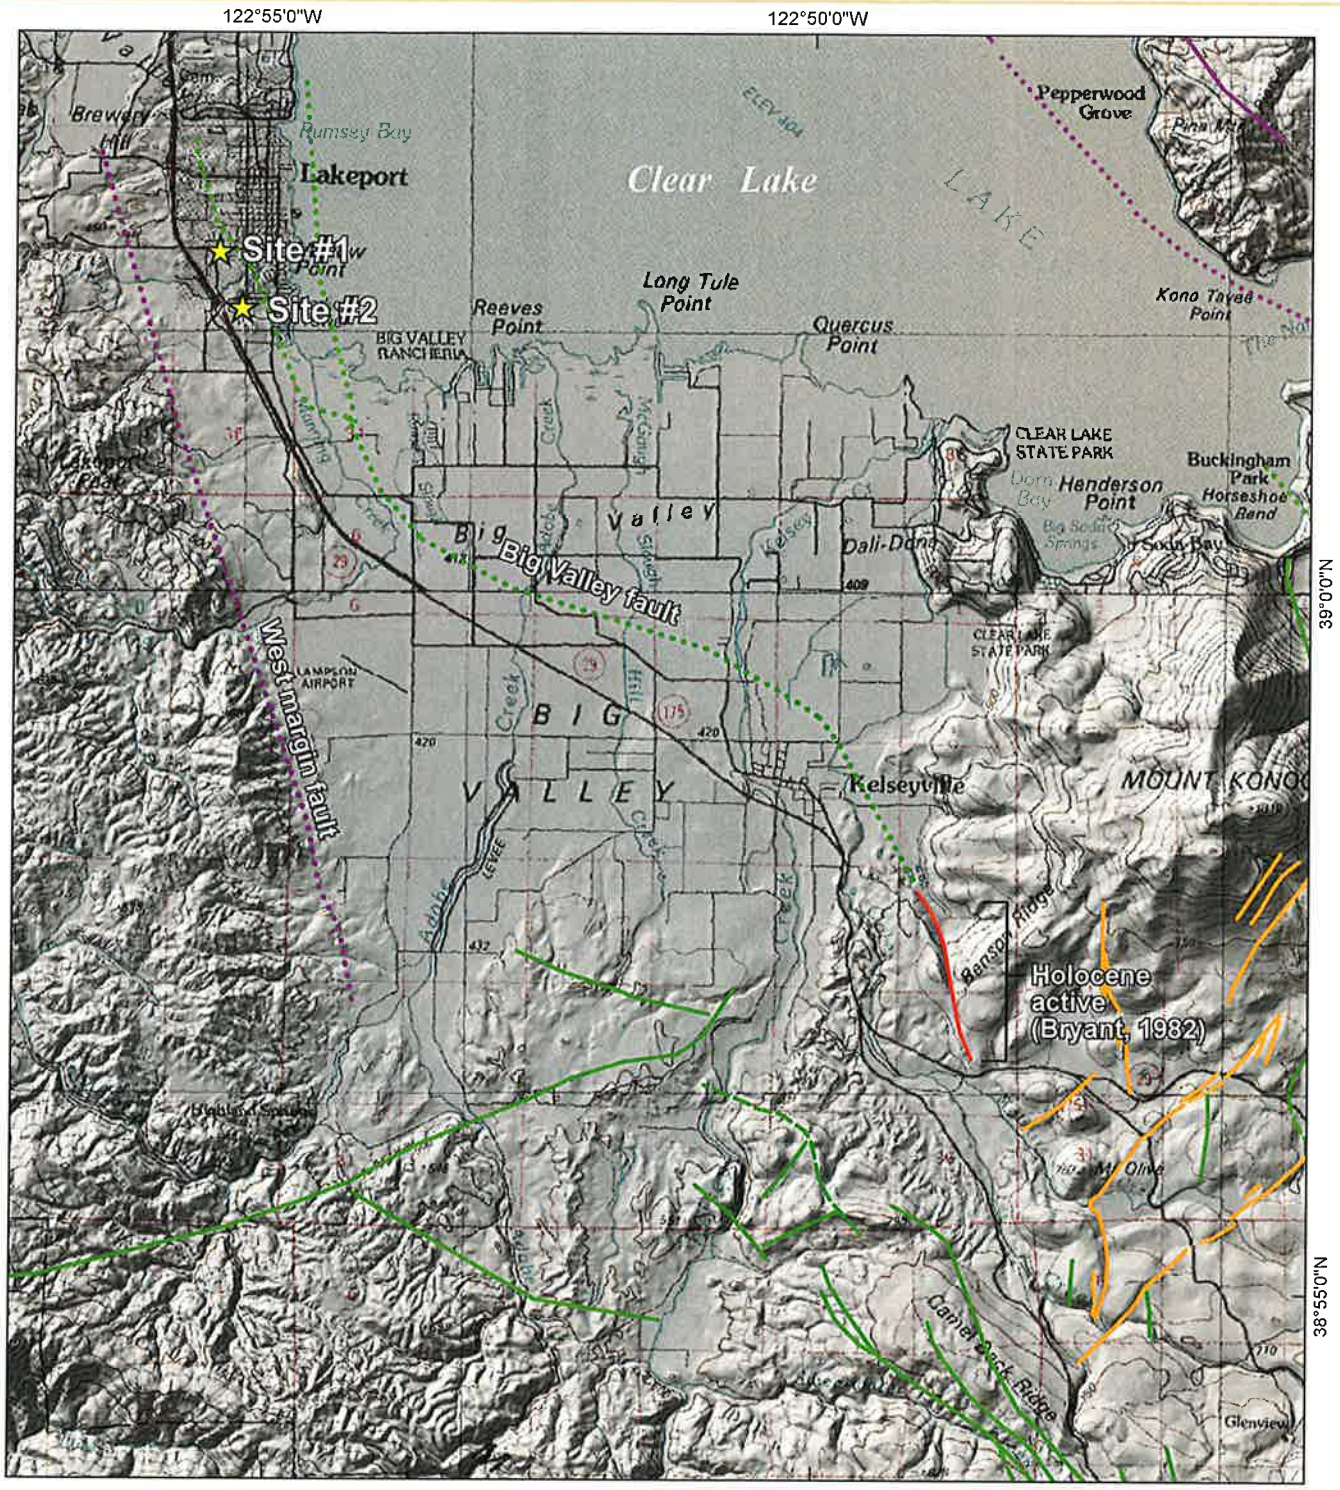
FIGURE 1

Quaternary faults compiled by the USGS and the CGS are shown on Figures 1, 2, and 3 (Bryant, 2005; Jennings and Bryant, 2010). The West Margin and Big Valley faults are shown on this and other compilation maps as north- to northwest-striking Quaternary faults, and are thus potentially active faults based on the Lake County General Plan. The West Margin fault and the eastern trace of the Big Valley fault are over 3,500 ft from both sites and therefore, are not considered a surface-fault rupture hazard. The alternative courthouse Sites #1 and #2 are located approximately 700 feet and 1,000 feet west of the western trace of the Big Valley fault, respectively (Figures 1 and 3) (Bryant, 2005). We have not reviewed all of the publications that have studied the Big Valley fault, but we infer from geologic mapping by McNitt (1967) (Figure 3) that the fault is associated with the north- to northwest-trending serpentinite knobs beneath the sites (unit sp on Figure 3). These serpentinite hills are surrounded by Quaternary terrace gravels (Unit Qt) and Quaternary lake deposits (Unit Ql) along the western margin of Clear Lake.

Based on the information available at this time, the Big Valley fault is a potentially active fault as defined by Lake County (2008) and should be considered a potential surface-fault rupture hazard. The exact location of the western trace of the Big Valley fault is uncertain based on the information available for review under this Tier 1 investigation. Based on the relatively short distance from the alternative courthouse sites to the approximate mapped trace of the fault and the highly uncertain location of the fault, we recommend that a Tier 2 investigation be performed to further evaluate and characterize the location of the western trace of the Big Valley fault in the direct vicinity of the alternative courthouse sites. Thus, the surface-fault rupture hazard is considered moderate at both Sites #1 and #2 and requires further investigation.

**Shaded Relief Map of Lakeport and Kelseyville Areas
 Showing Alternative Sites and Quaternary Faults**

Based on the presence of a poorly located, potentially active fault within about 1000 feet of both alternative courthouse sites and poorly characterized liquefaction hazard, we recommend a Tier 2 investigation be performed to further assess the surface-fault rupture and liquefaction hazard at Site #1 and #2. The scope of the Tier 2 study would include additional map and literature

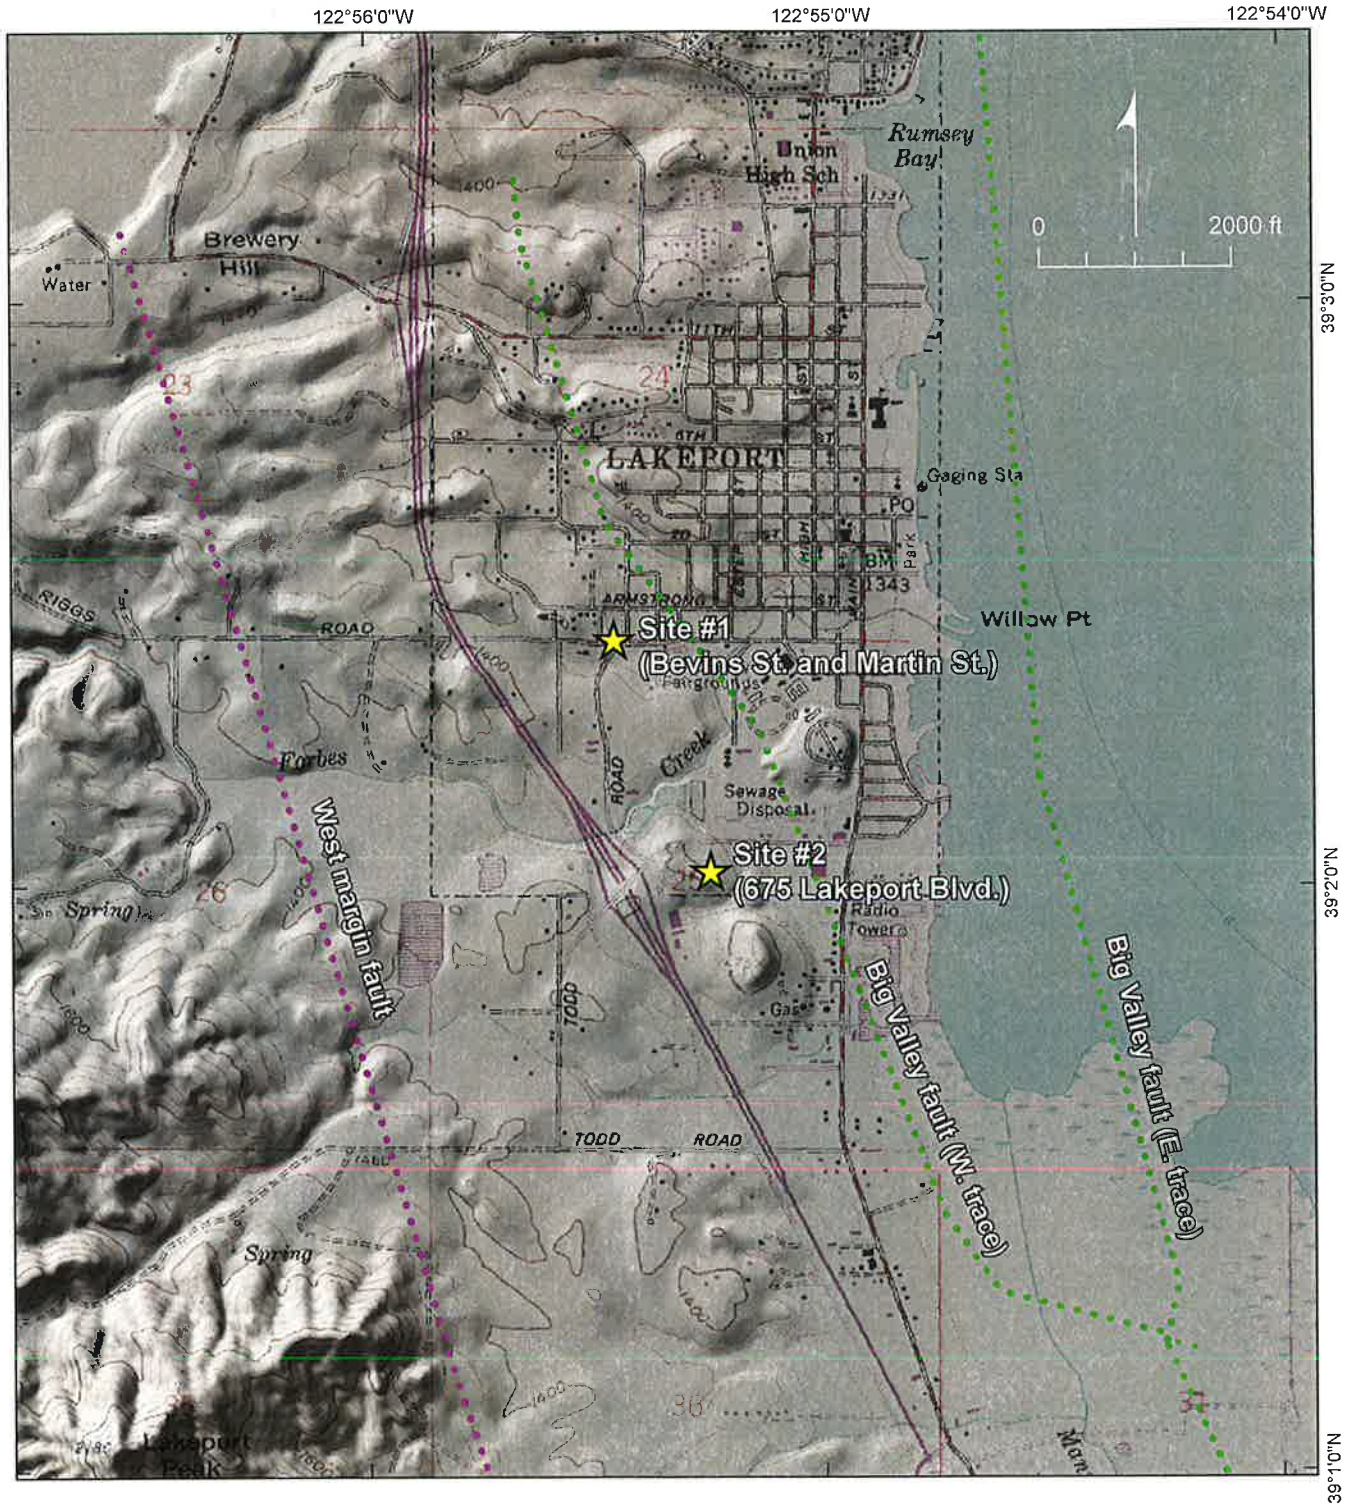
FIGURE 2

As seen from the topography on Figures 2 and 3, both Sites #1 and #2 are located on gentle slopes (less than 20 percent). Geologic mapping by McNitt (1967) indicates that Site #2 is underlain by serpentinite (map unit sp) on top of a ridge (Figure 3). Based on the geologic map, Site #1 is underlain by Quaternary lake deposits (map unit Ql) and potentially underlain by Young Terrace deposits (map unit Qt) adjacent to serpentinite bedrock. Regardless, there are no mapped landslides at either site based on available information and the gentle slopes (<20%) adjacent to the two sites indicate that the earthquake-induced landslide hazard is likely low for the two sites.

Although not included in our scope of work, we note that Site #2 is located on serpentinite bedrock (Figure 2). According to the Lake County General Plan, development of this site may require engineered plans and/or a geotechnical study prior to site approval due to the possible presence of naturally occurring asbestos in serpentinite bedrock. Evaluation of asbestos potential is beyond the scope of this seismic hazards study.

Lakeport Courthouse Alternative Sites

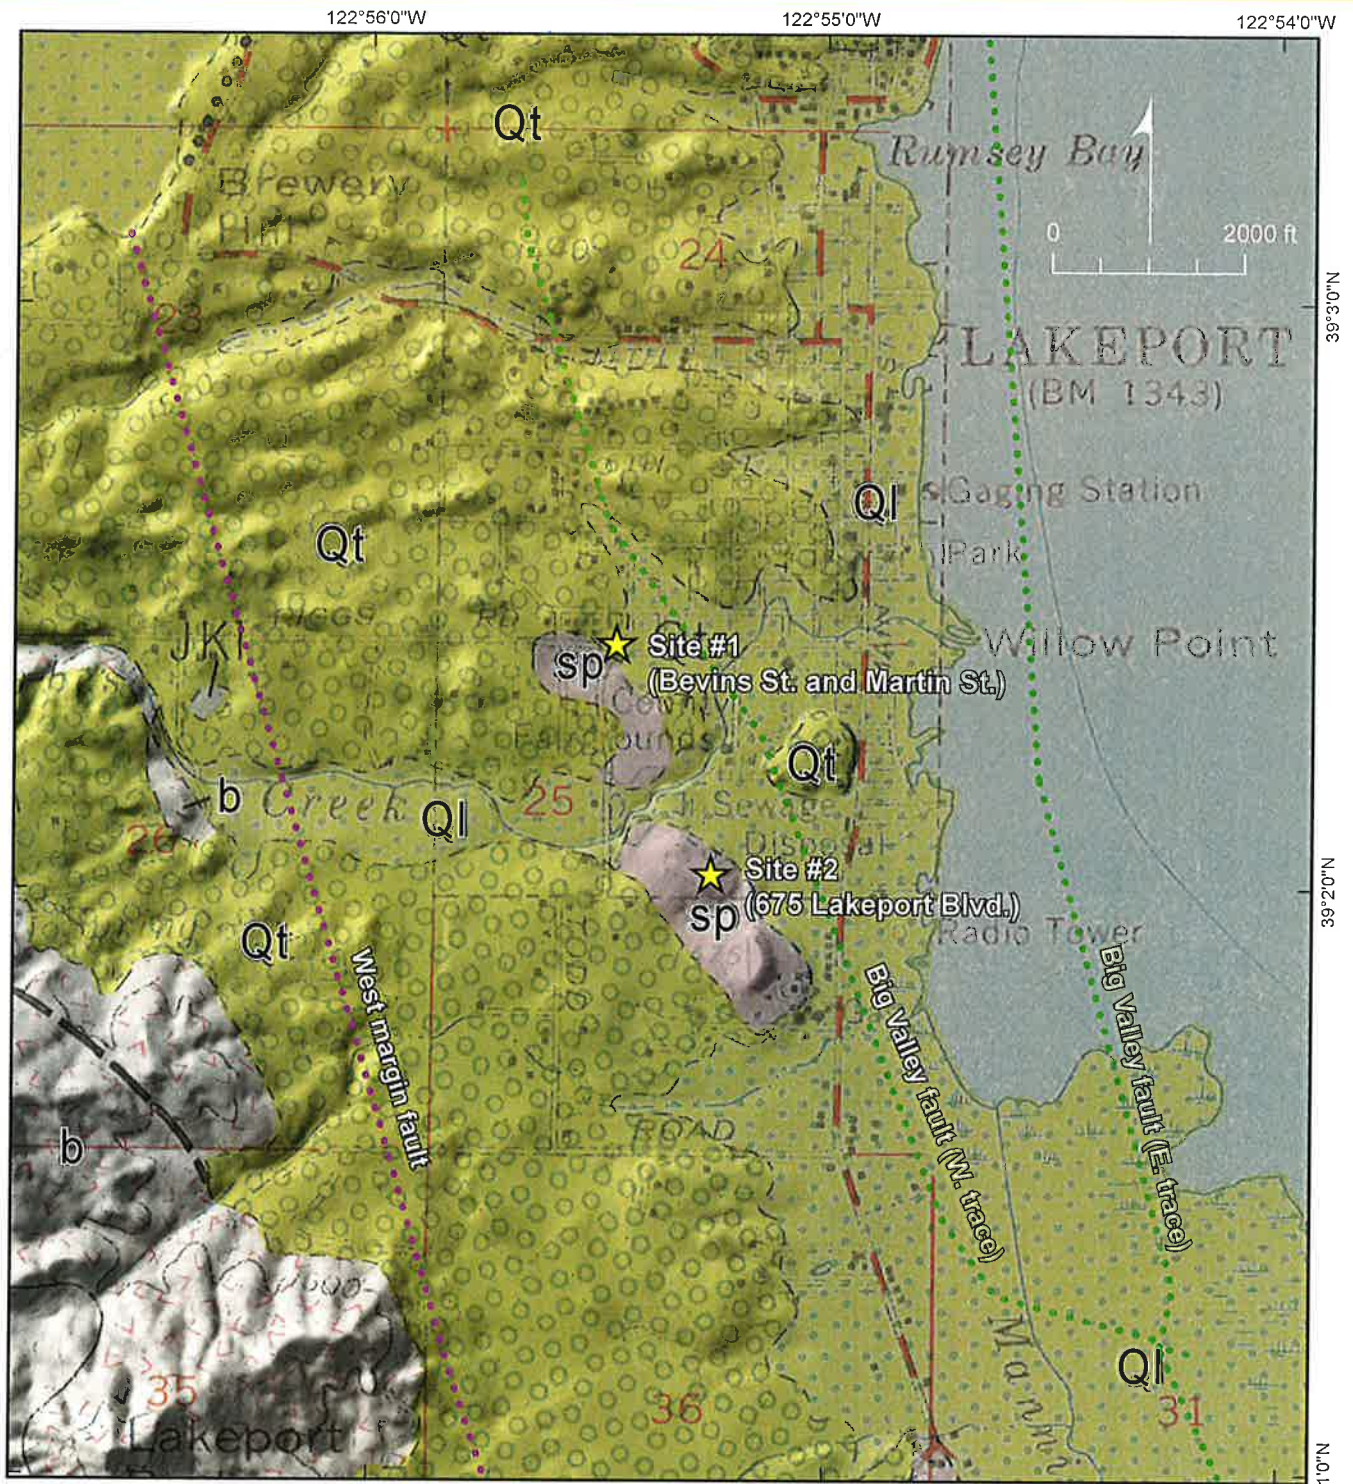
FIGURE 3

The liquefaction hazard at the alternative courthouse sites can be estimated based on the available geologic map. As discussed above, Site #2 is located on serpentinite bedrock and thus the liquefaction hazard is very low. The liquefaction susceptibility is uncertain at Site #1. The unconsolidated Quaternary alluvium (Units Qt and Ql) underlying Site #1 (Figure 3) may include deposits susceptible to liquefaction (typically loose fine sand and silt). The thickness

Lakeport Geologic Map

Due to the lack of liquefaction susceptibility mapping and information on the local soil conditions at the sites, we recommend a Tier 2 investigation to further evaluate the liquefaction hazard for both sites.
