**NEW SAN DIEGO CENTRAL COURTHOUSE
FOR THE SUPERIOR COURT OF CALIFORNIA, COUNTY OF SAN DIEGO:
FINAL ENVIRONMENTAL IMPACT REPORT**

Issue Date: December 2010

VOLUME II: TECHNICAL APPENDICES

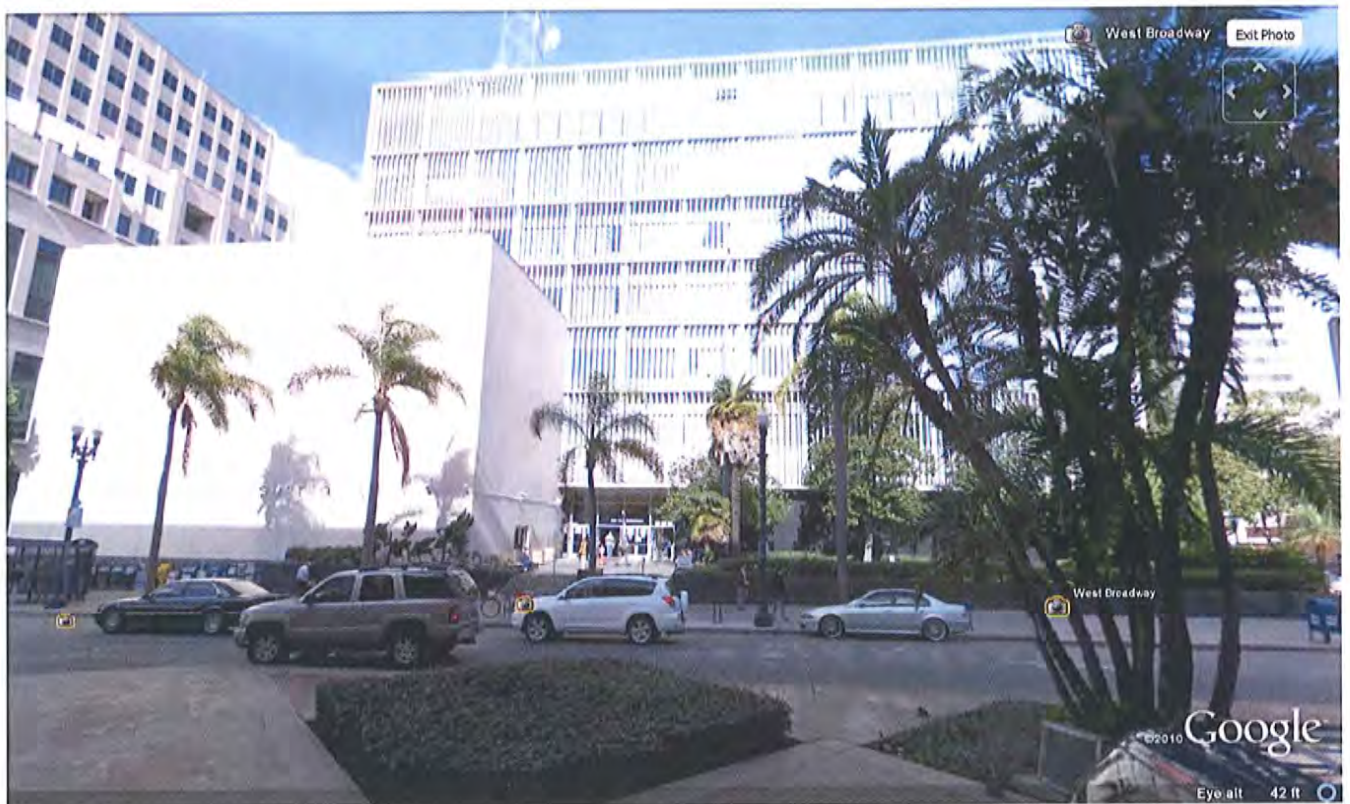
The San Diego County Courthouse and Detention Center Complex can be characterized as structures with a plain utilitarian form, which lack historical or architectural significance, and do not exhibit character-defining exterior architectural devices. Lacking any distinctive architectural features or other historically noteworthy characteristics, the Complex is determined not to be a significant historic resource under CEQA (which incorporates the provisions for the California Register of Historic Resources). Moreover, the same lack of historic and architectural significance falls short of meeting the criteria needed to qualify for listing on the NR.

Plate 2: View of existing County Courthouse, taken from south side of West Broadway and Front Street, photograph facing north

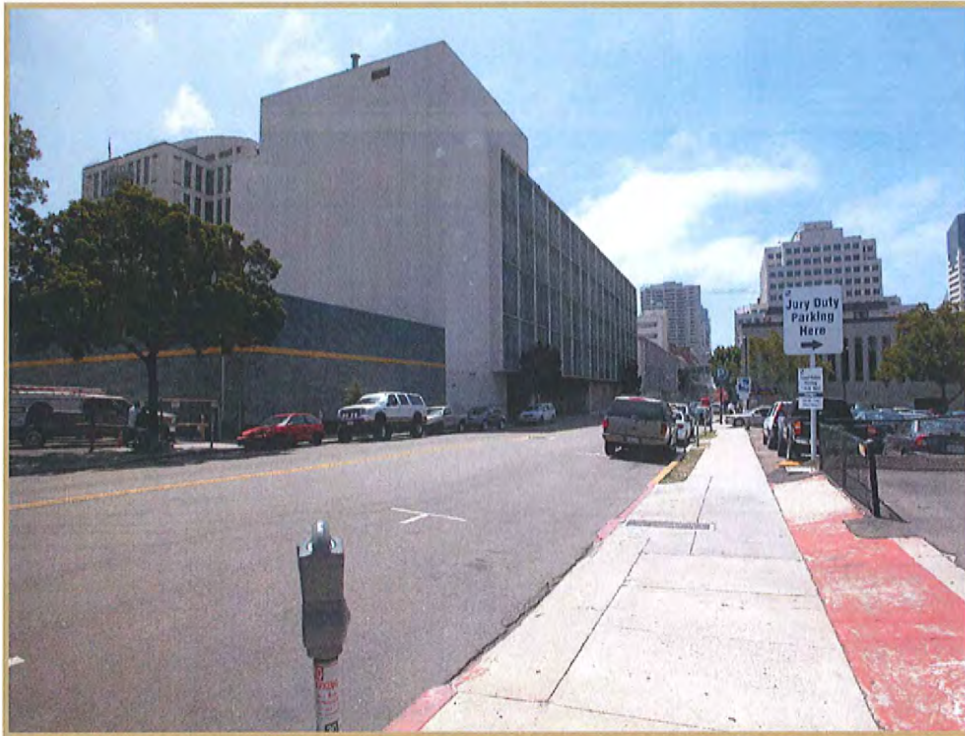
The San Diego County Courthouse and Detention Center Complex is aging and exhibits deferred maintenance. The State and County need newer facilities designed for the present conditions and built using modern materials. Moreover, the existing County Courthouse Complex does not make the most efficient use of land in an area of very high real estate values. As a result, the County Courthouse Complex buildings are slated for demolition as part of the development of the New San Diego Central Courthouse. Although nothing in this evaluation identified absolute neglect, as only the exterior of the complex was examined, the overall appearance reflected the age of the buildings with some wear and tear in the form of worn entries, oxidized window frames, and fading exterior building color for example. The overall appearance is less than efficient when compared with the newer Federal Courthouse Complex across Broadway to the south of the project area.

Plate 3: View of Detention Center, taken from west side of Union Street, facing northwest

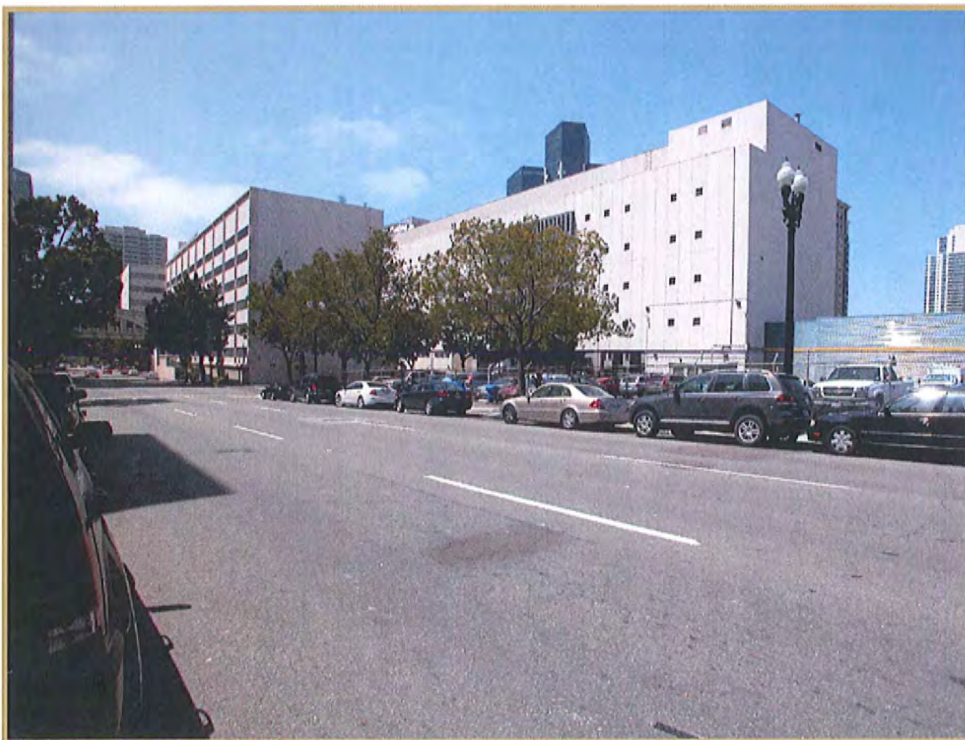
Plate 4: View of Detention Center, taken from east side of Front Street, facing south-southeast

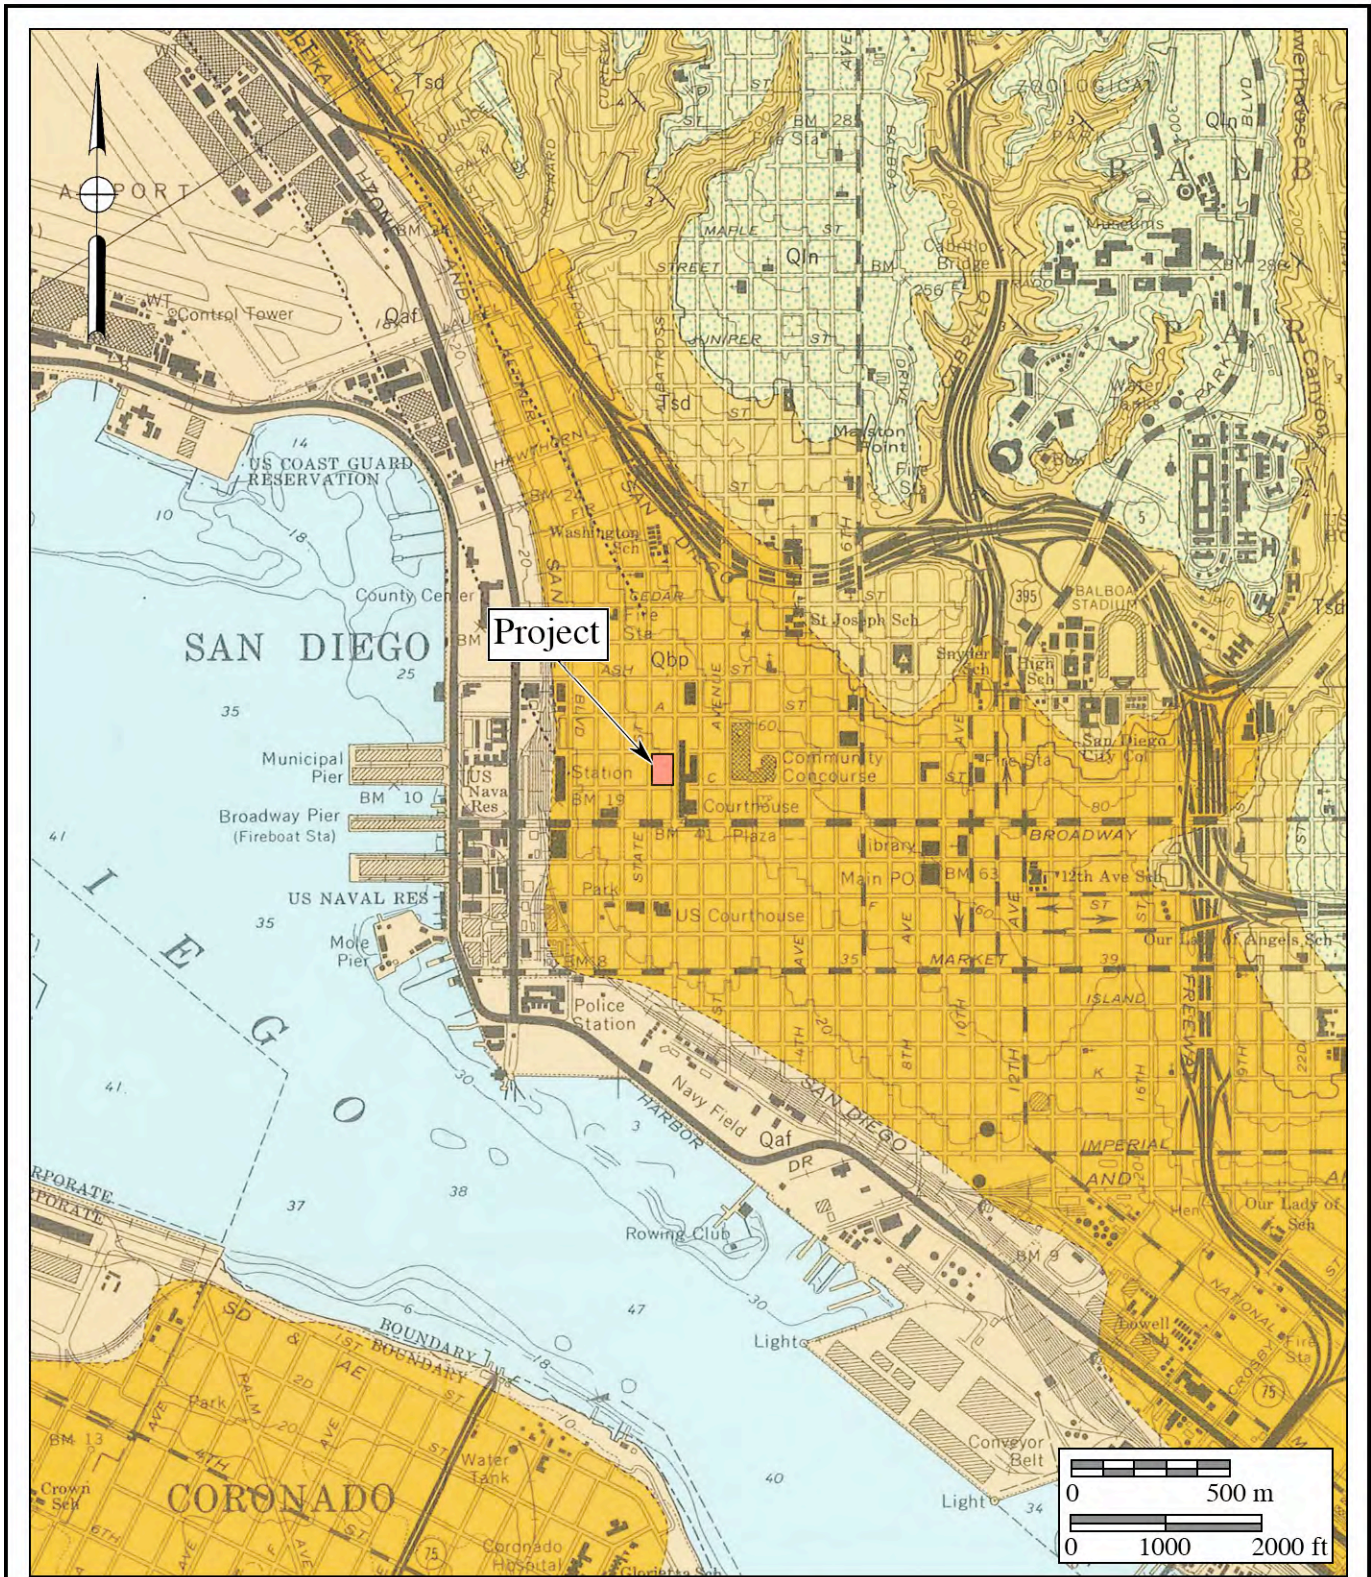
Attachment 4

Geologic Map
