Superior Courts of California
Seismic Assessment Program

Summary Report of Preliminary Findings

Prepared by
Rutherford & Chekene Consulting Engineers

January 2004

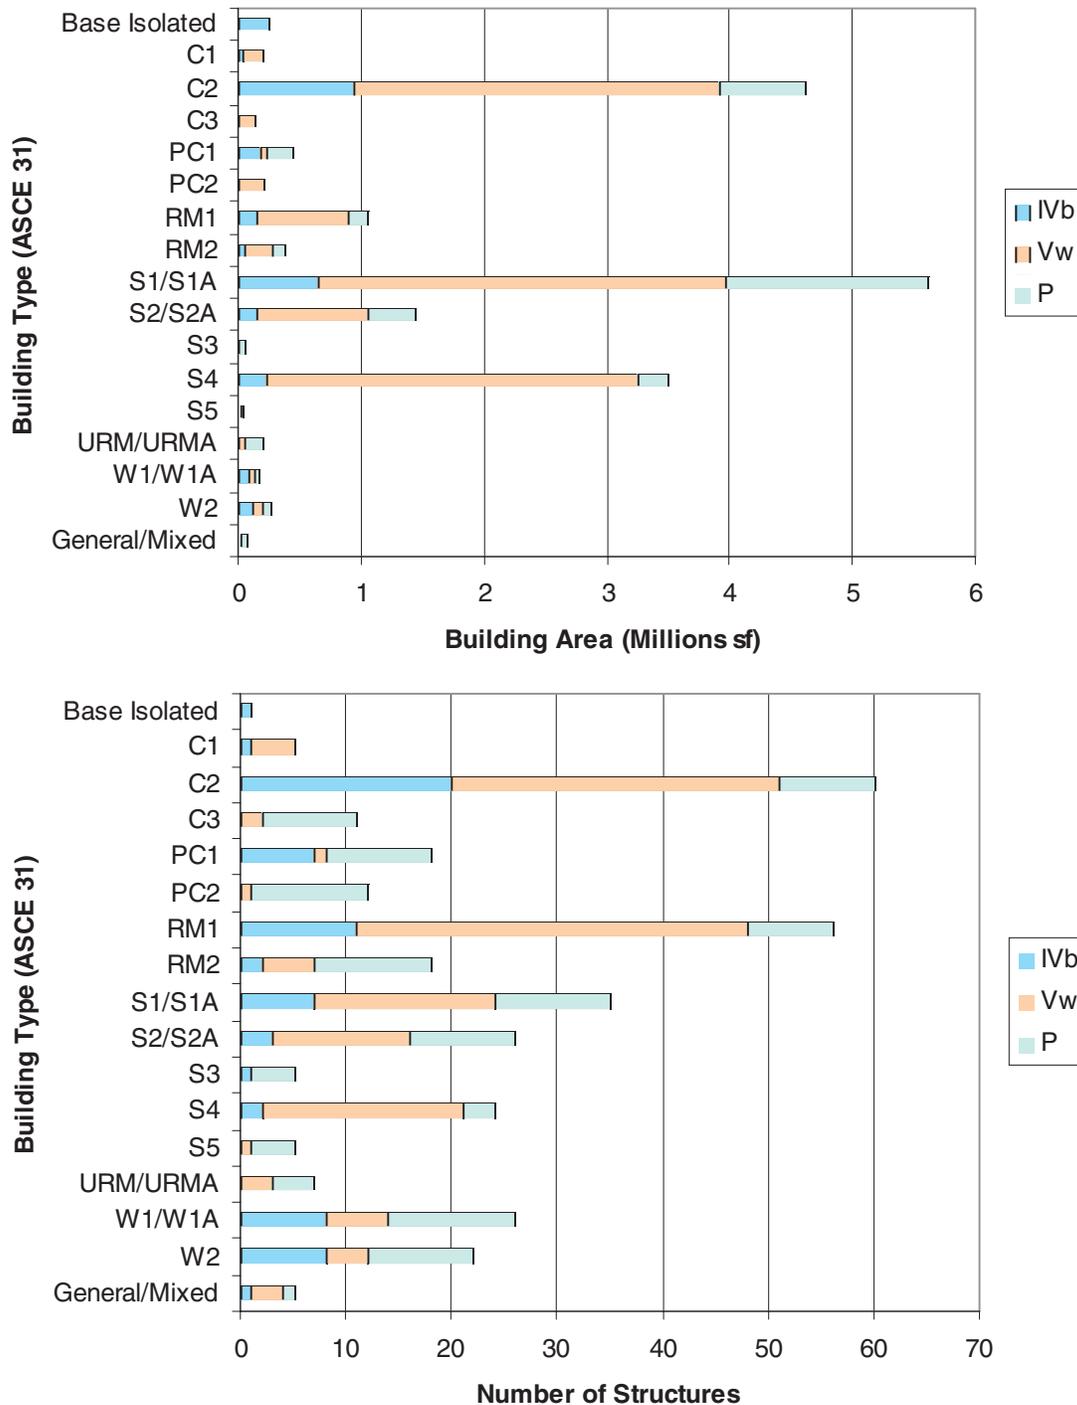
Figure 1. Preliminary Number and Area of Structures Meeting and Not Meeting Evaluation Standards by Building Type. (See the Detailed Matrix at the end of this section for a legend of Building Types.)

Figure 1 shows the total number of structures and the total area of structures classified into each of the model building types used in the ASCE 31 evaluation standard. A legend for the abbreviations used for building types is included with the expanded summary matrix at the end of this section. Each bar is split into the quantity meeting and not meeting the standard set forth in the Trial Court Facilities Act of 2002, or currently classified as pending. As shown, over half of the court facilities are housed in buildings with lateral systems of concrete shear walls (concrete framing systems, type C2) and steel moment frames (type S1). Another 18% are in steel frame buildings with concrete shear walls (type S4). These structural systems are commonly used for larger buildings in urban areas. On the other hand, the largest numbers of structures are not constructed of steel, but of

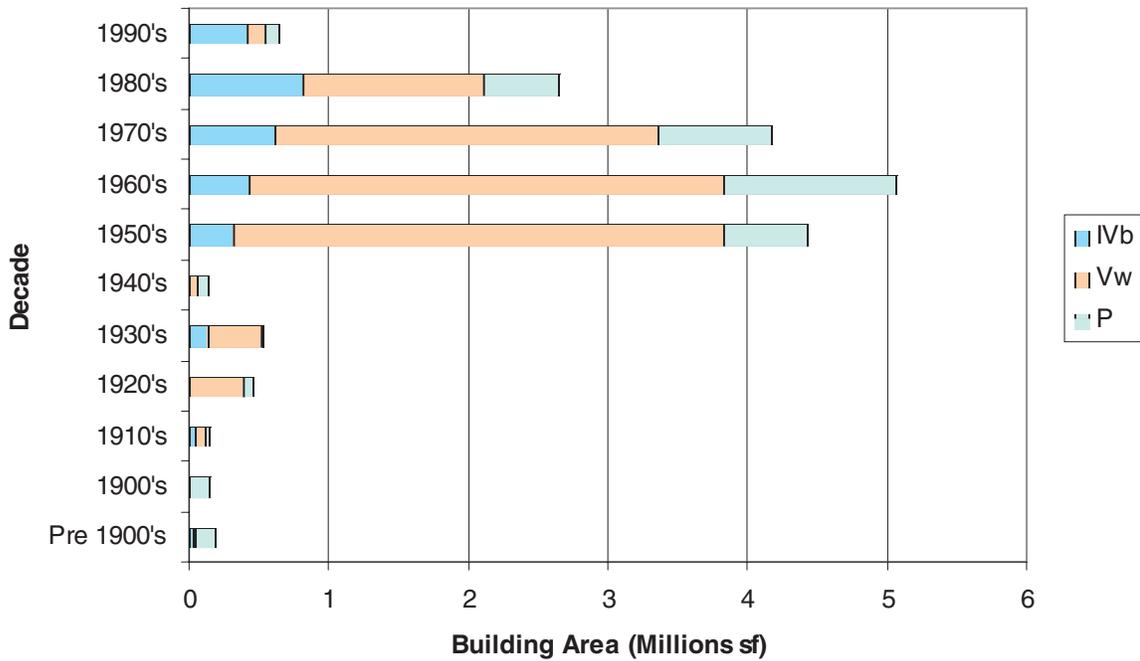
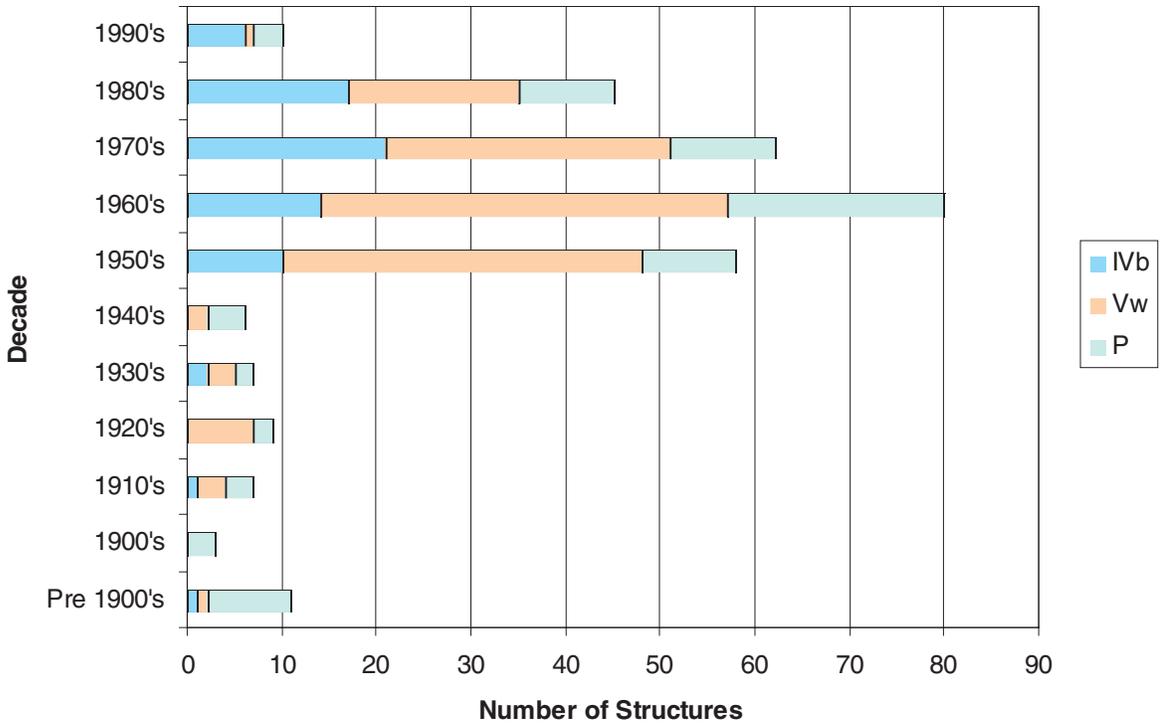
Figure 2. Preliminary Number and Area of Structures Meeting and Not Meeting Evaluation Standards by Age.

Dates of construction were associated with each building during the initial collection of the inventory, although they were poorly defined. In some cases the dates entered were apparently dates of preparation of construction-related documents and in other cases appeared to be the completion of construction. During the program the date of construction completion and/or the date of design were clarified where possible; this is reflected in the Expanded Summary Matrix. In any case, these dates can be used to group buildings roughly into decades of construction, as shown in Figure 2. Both area of construction and number of structures are shown and, similar to Figure 1, the bars are split into the quantity meeting and not meeting the evaluation standard, or currently classified as pending. A trend can be seen that a larger percentage of more recently constructed buildings meet the standard, as would be expected. Over 70% of the current court building area was constructed in the 1950's, 60's, or 70's, a period for which code design requirements, particularly for concrete, are now considered inadequate.
