# **Seismic Renovation Project Feasibility Report**

NAPA COURTHOUSE  
28-B1

825 BROWN ST., NAPA

PREPARED BY ARUP  
JANUARY 22, 2019

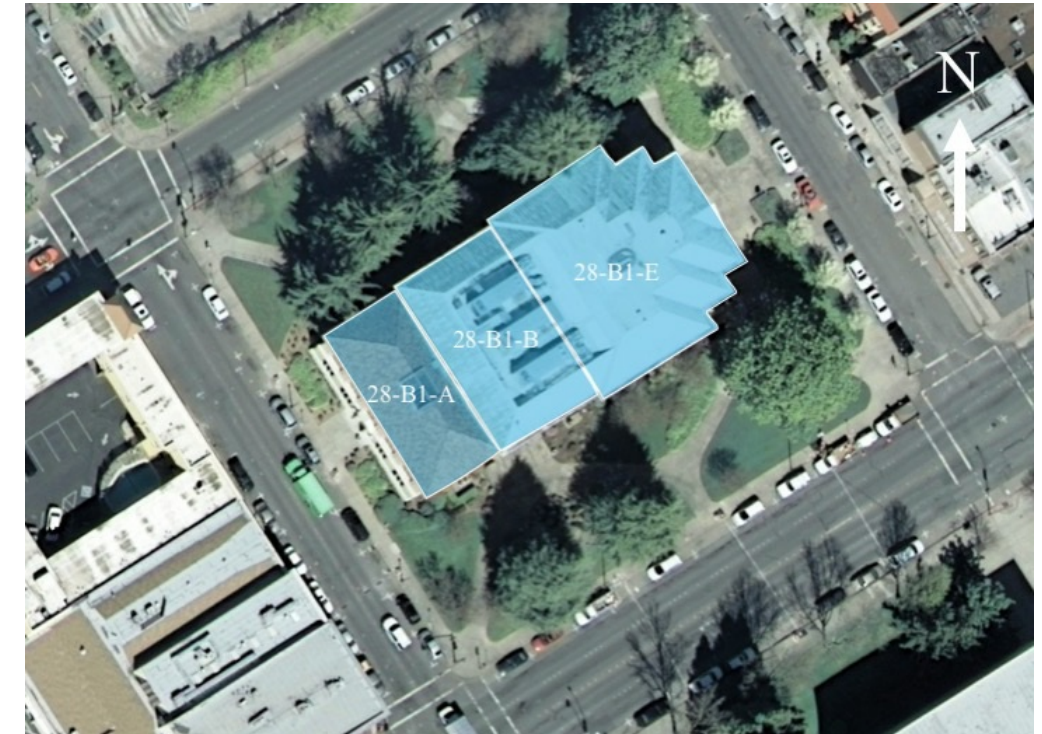
**Overall facility condition**

- Structural**
- Refer to retrofit drawings for full list of seismic deficiencies
  - Seismic joint width between Segments E and B inadequate; no seismic joint between Segments A and B

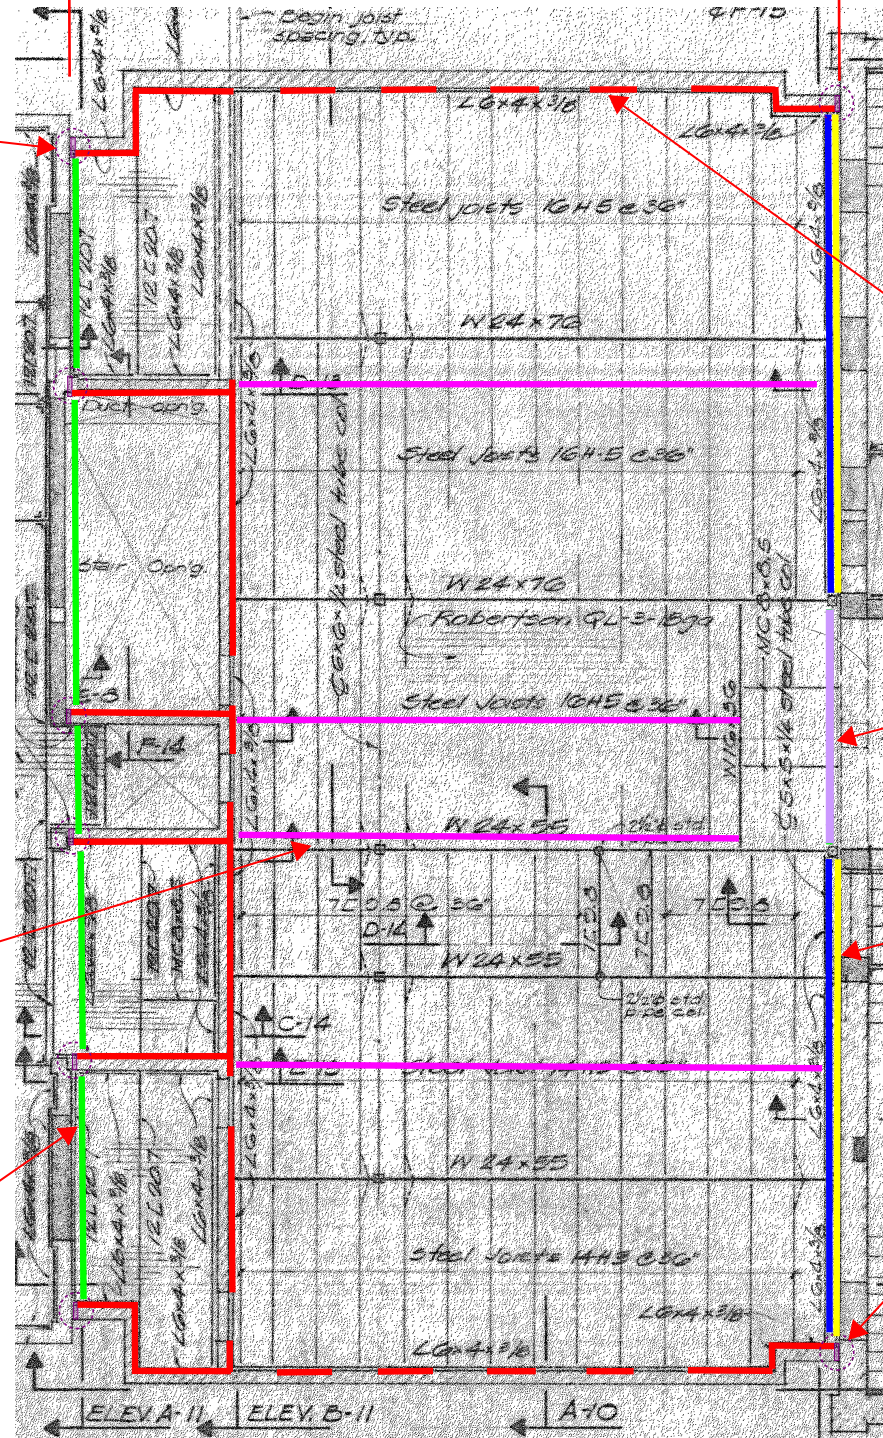
**Item 1** Strengthen walls (highlighted in red)

**Item 6** Provide a steel beam to support the stair and create a 3" wide seismic joint (highlighted in light purple)

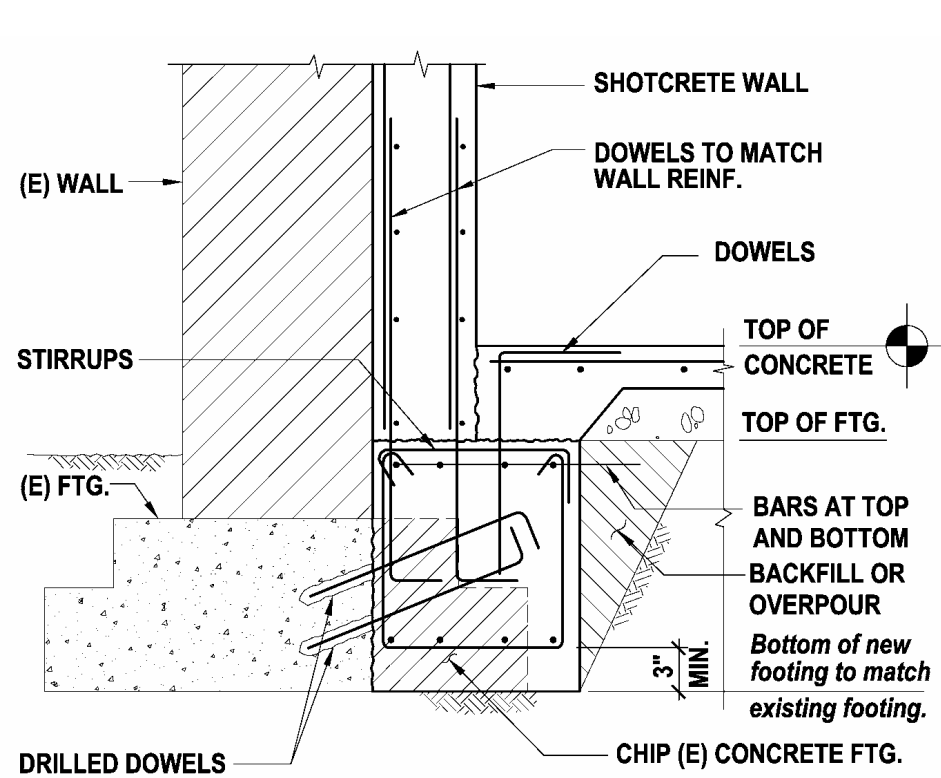
RETROFIT DETAIL 3: Sample Detail of Strengthening Existing Concrete Wall Footing

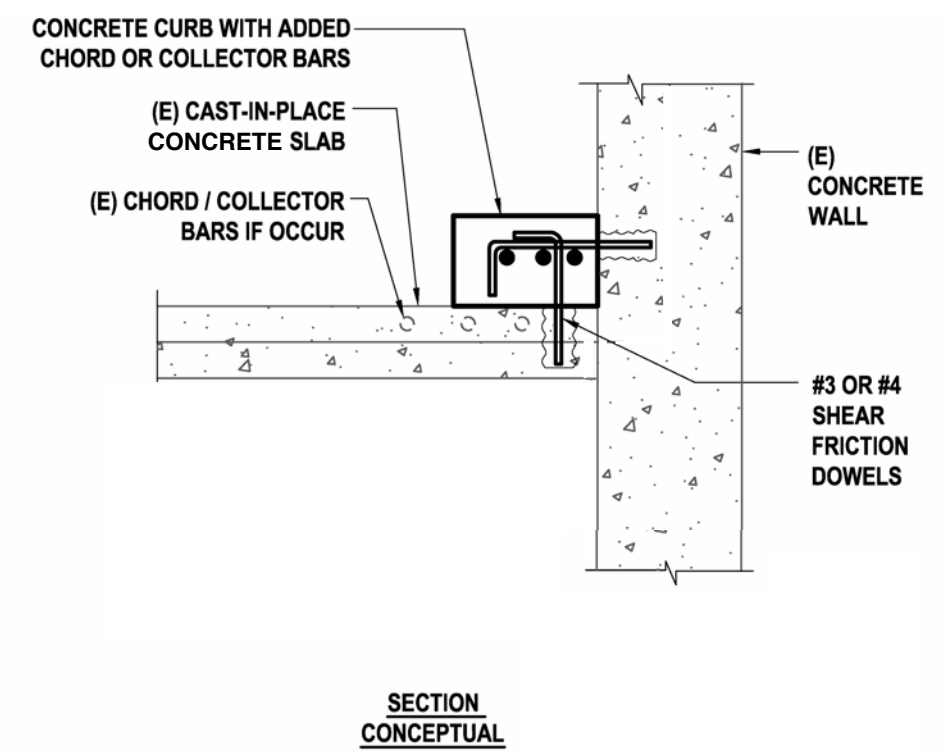
RETROFIT DETAIL 6: Sample Detail of Add Chord and Anchorage to Shear Wall

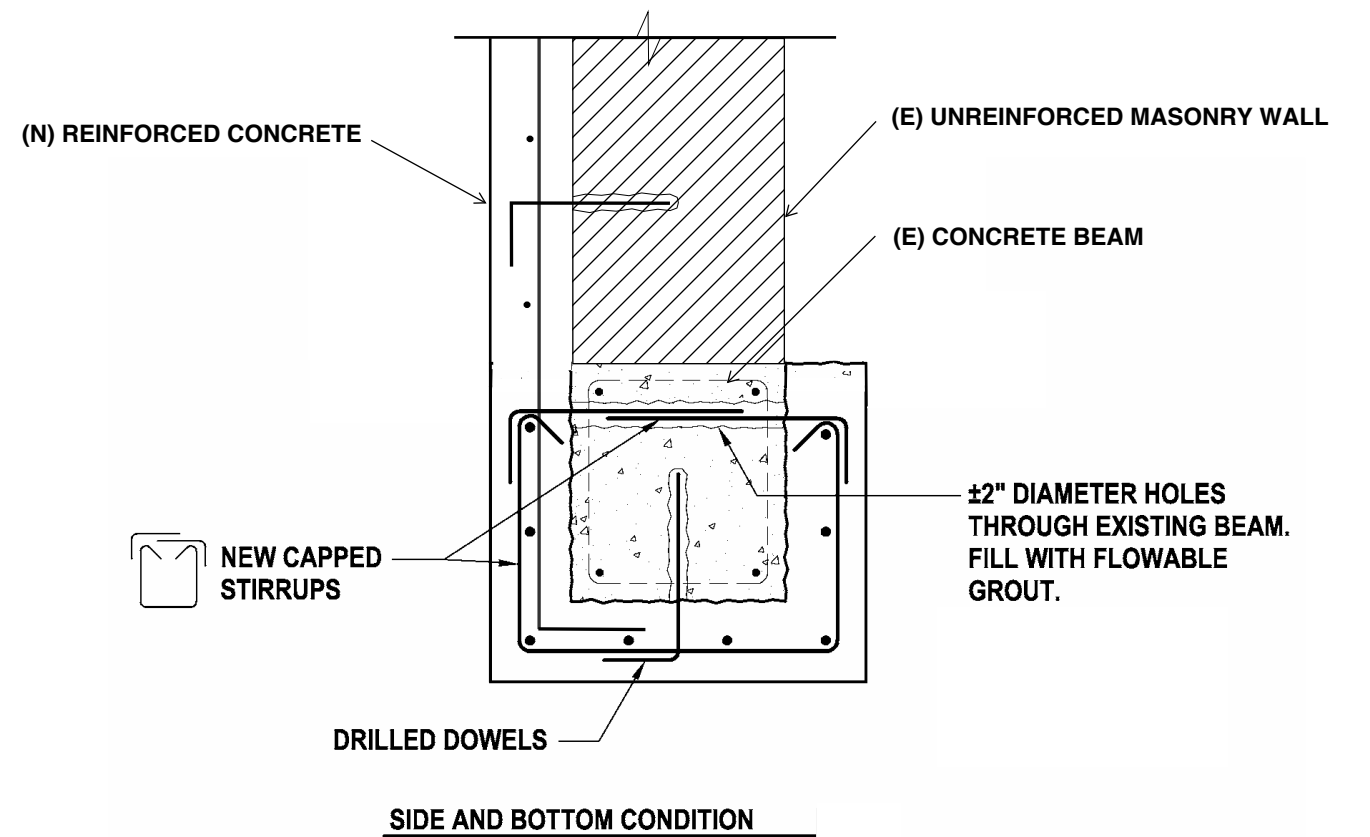
**RETROFIT DETAIL 16: Sample Detail of Strengthening Existing Concrete Beams**
