Seismic Renovation Project Feasibility Report

GEORGE D. CARROLL
COURTHOUSE
07-F1

100 37TH ST., RICHMOND

PREPARED BY ARUP
JANUARY 22, 2019

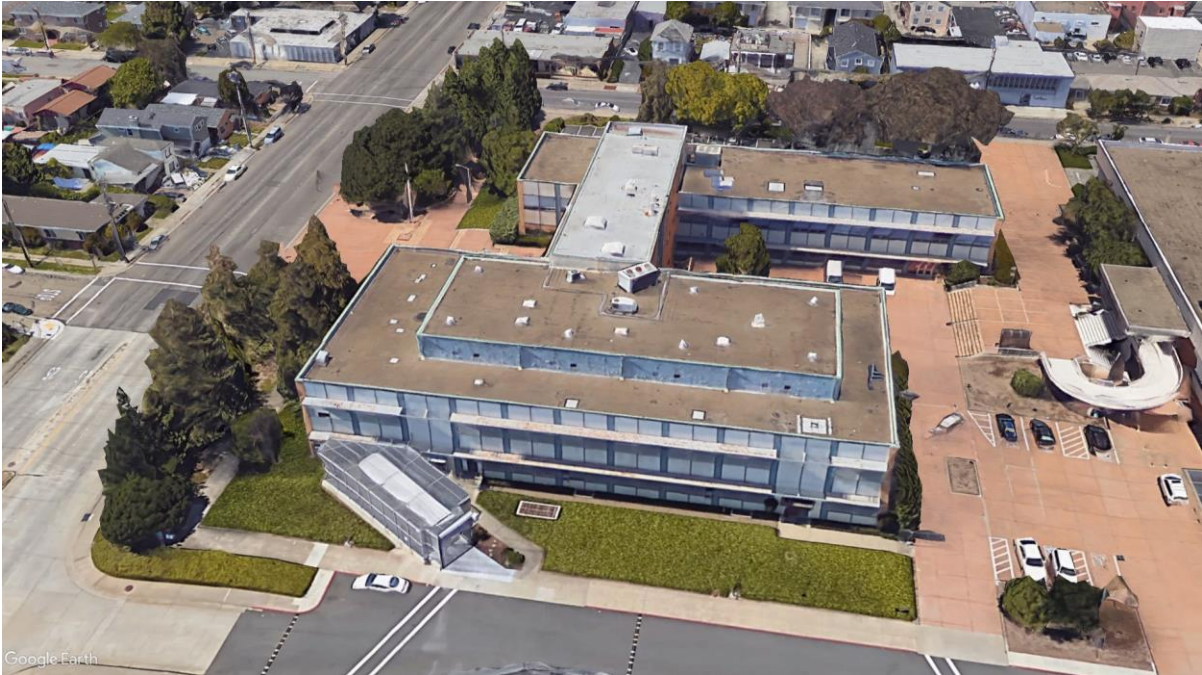
Figure 1. Satellite Image Showing an Overview of the Court Building (Source: Google Earth)

Figure 1 provides a satellite image of the court building showing its overall configuration and construction. Figure 2 provides a satellite image of the court building overlaid with information about each building segment.

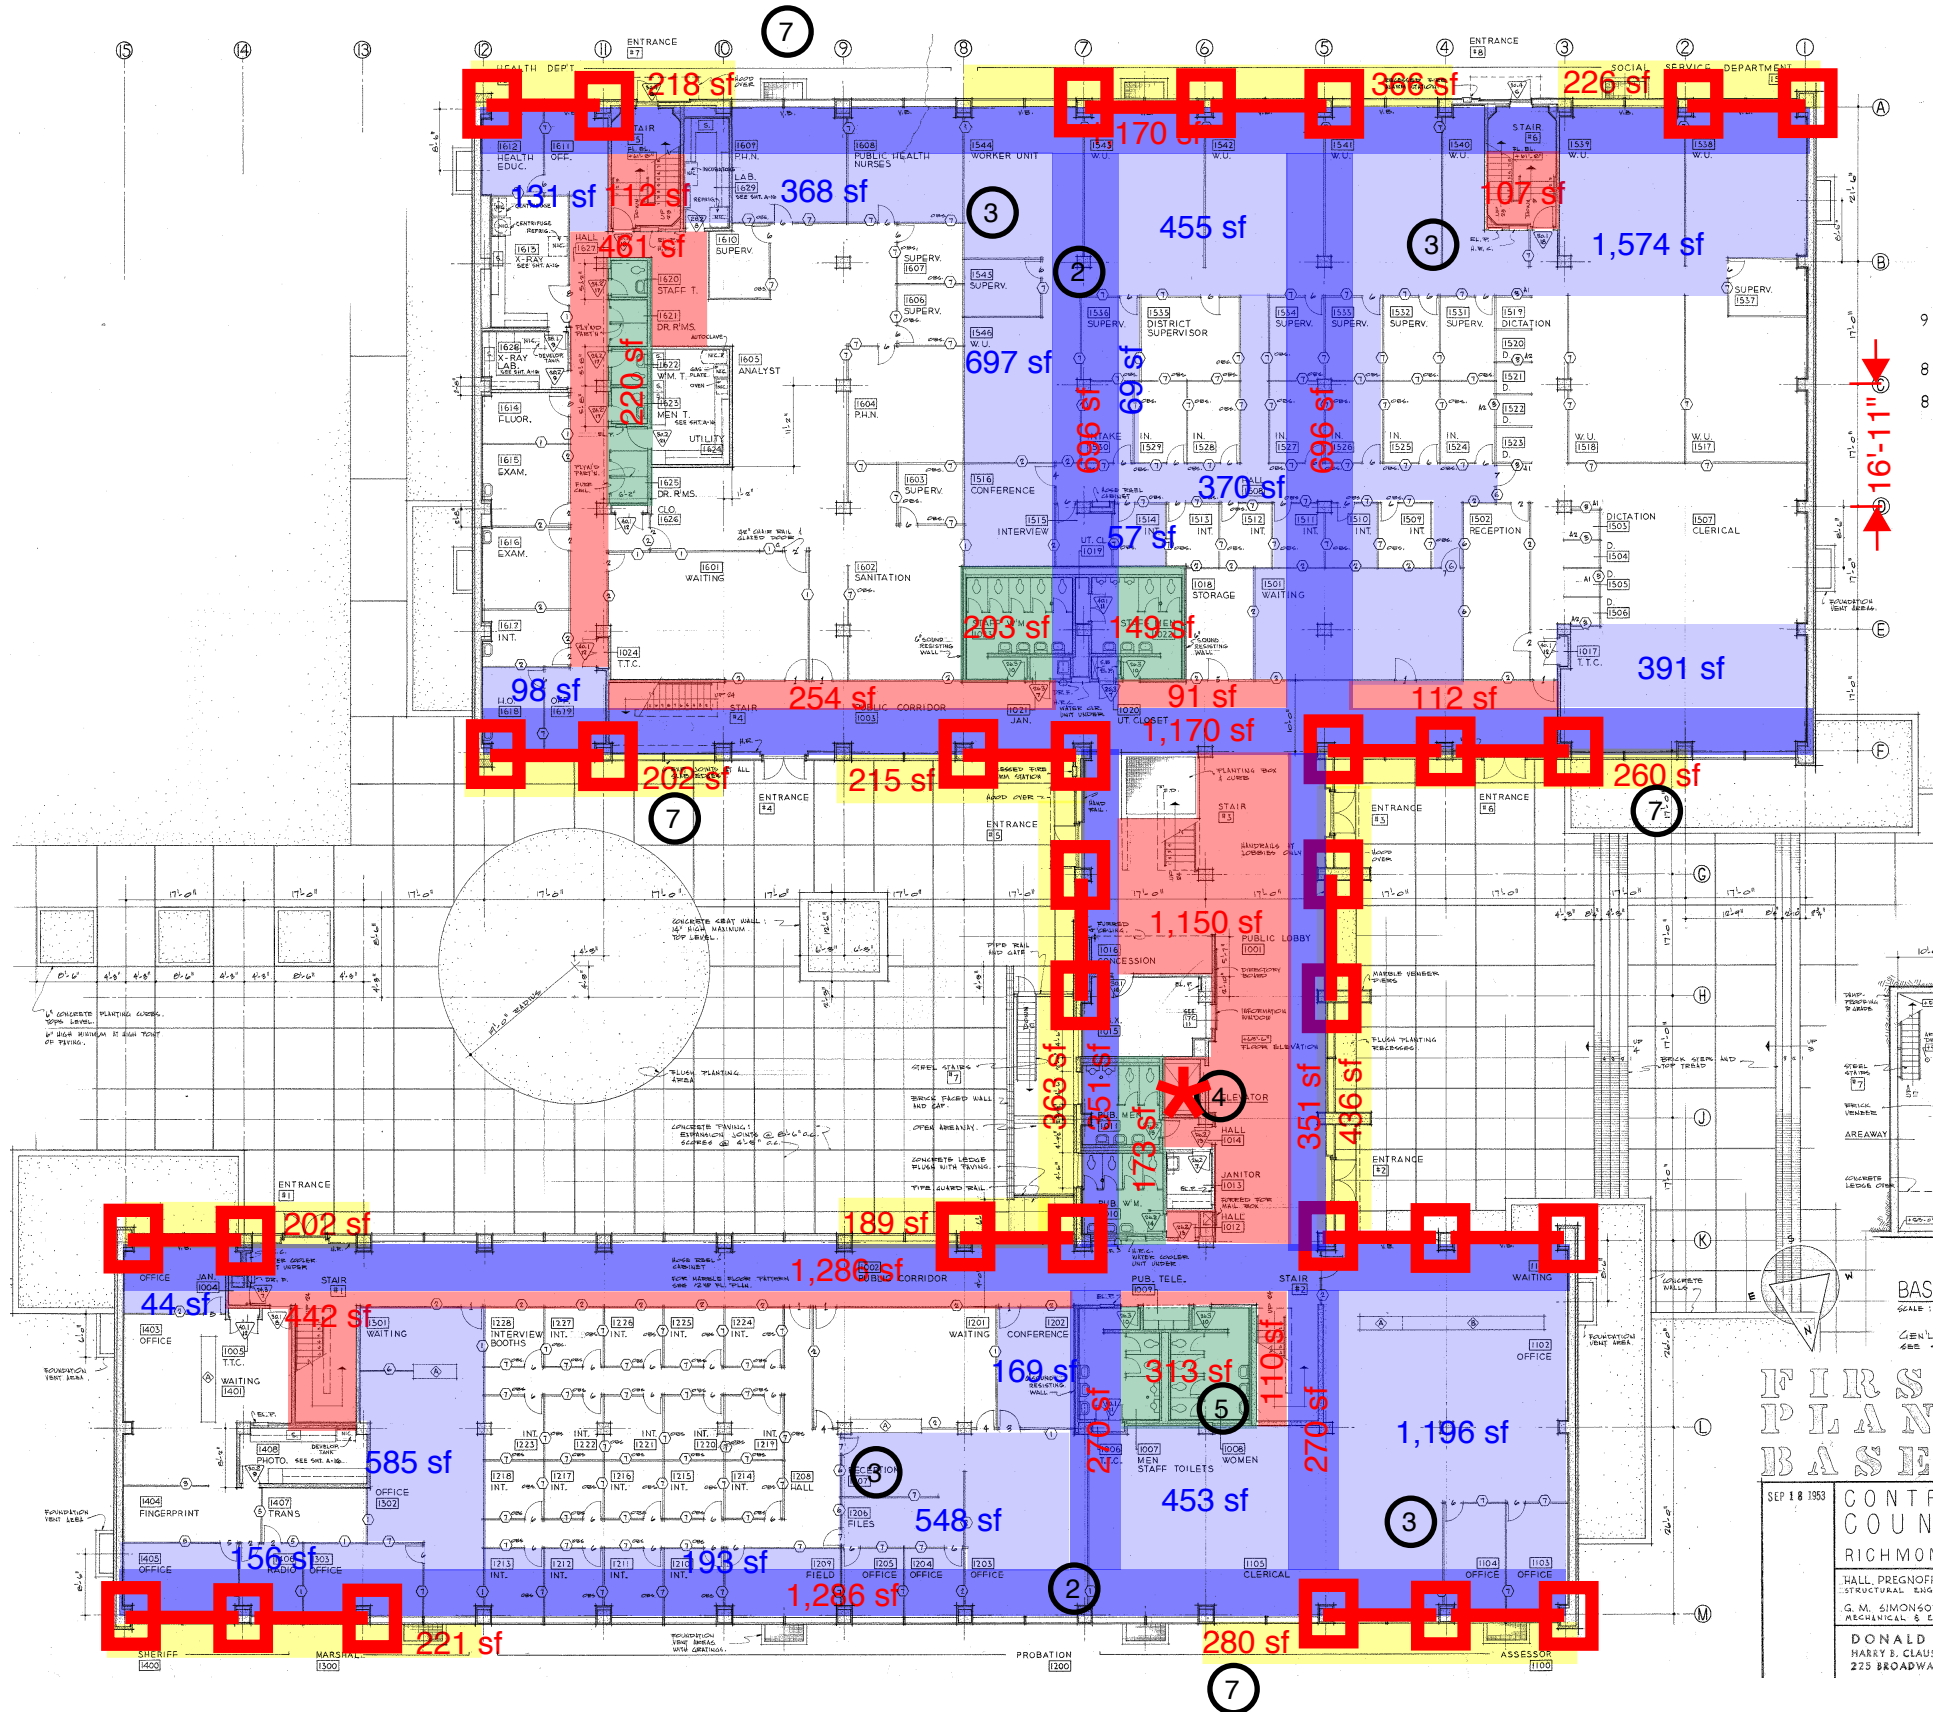
Sketch No:
A2.00 - FIRST FLOOR PLAN

Retrofit: RICHMOND
Scale: NTS
Description: ARCHITECTURAL UPGRADES

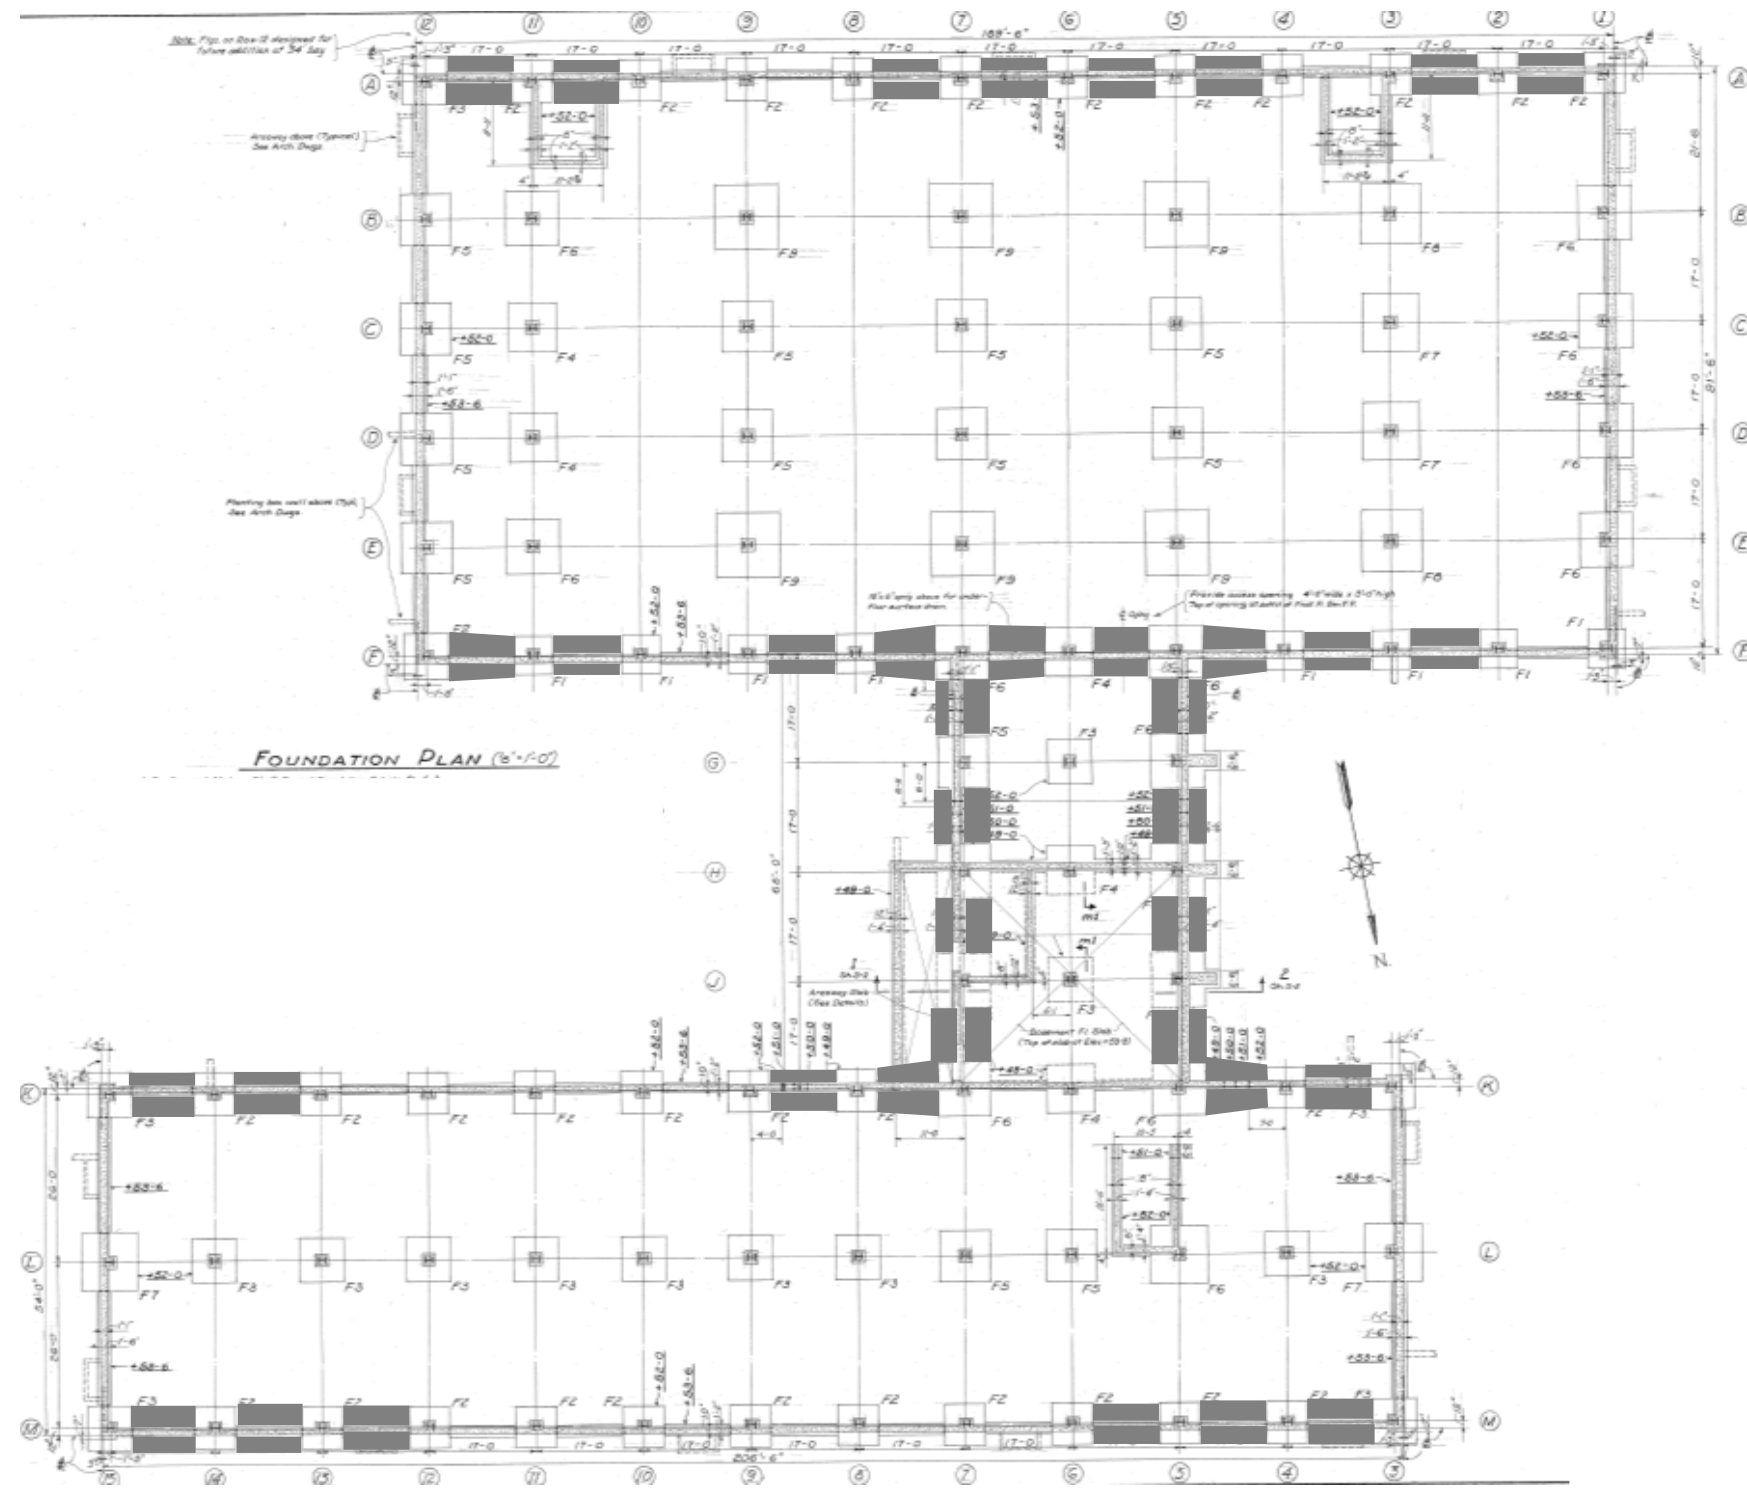
Job: Judicial Council	Job #: 259713
Title: 07-F1 George D. Carroll Courthouse Seismic retrofit scheme	
Prepared By: SF	Page: S2
Sketch #: Foundation plan	ARUP
Date: 2018-05-25	
Scale: NTS Original paper size: 11" x 17"

Excavate, install dowels into (E) foundations, and pour new foundation, same depth as (E) foundations

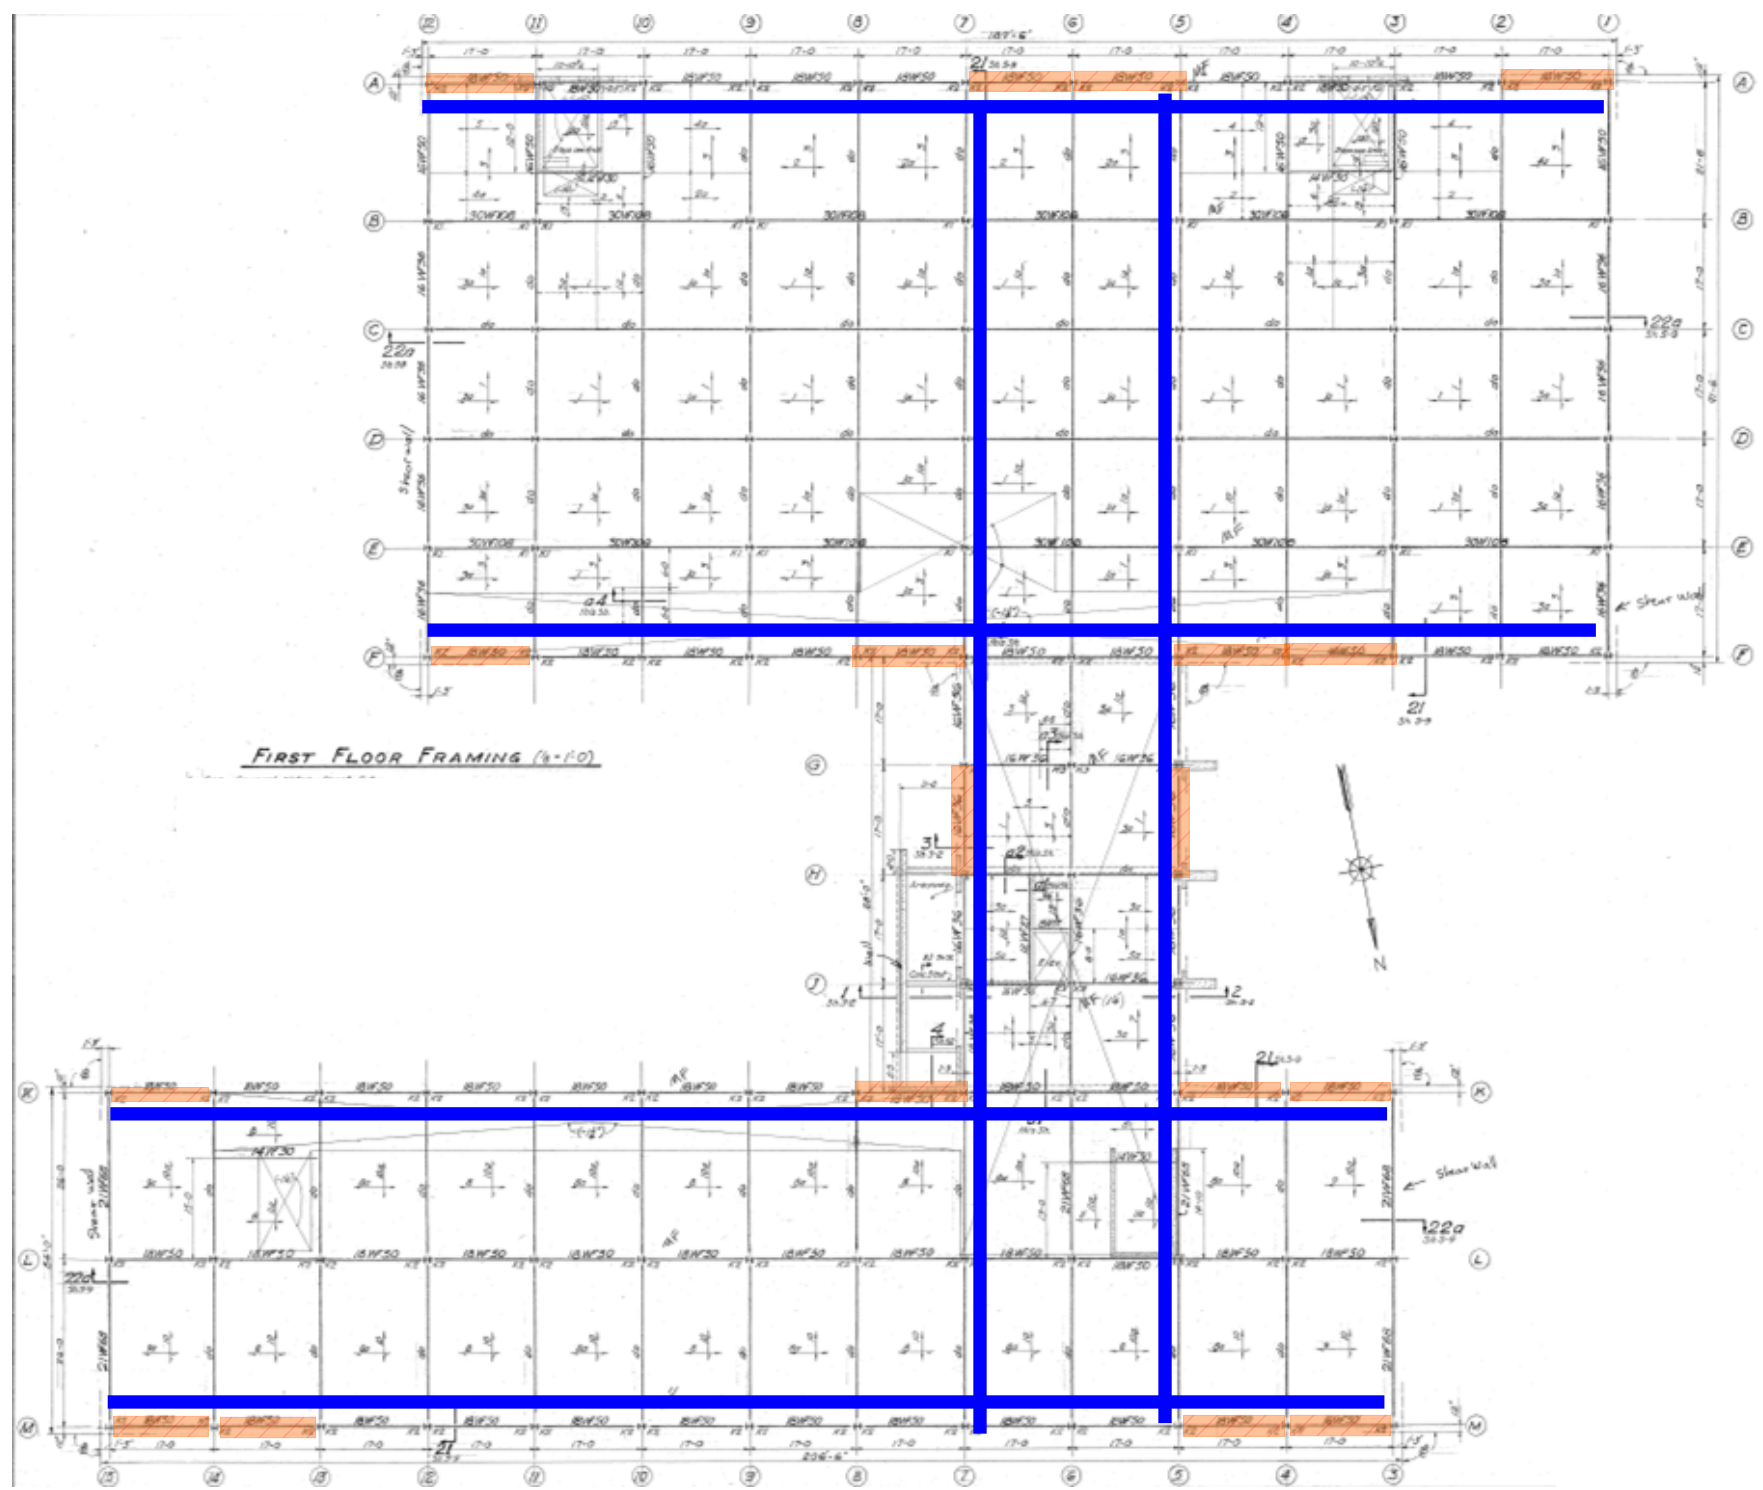
FIRST FLOOR FRAMING (1/10)

Install uni-directional FRP overlay on top of slab
3

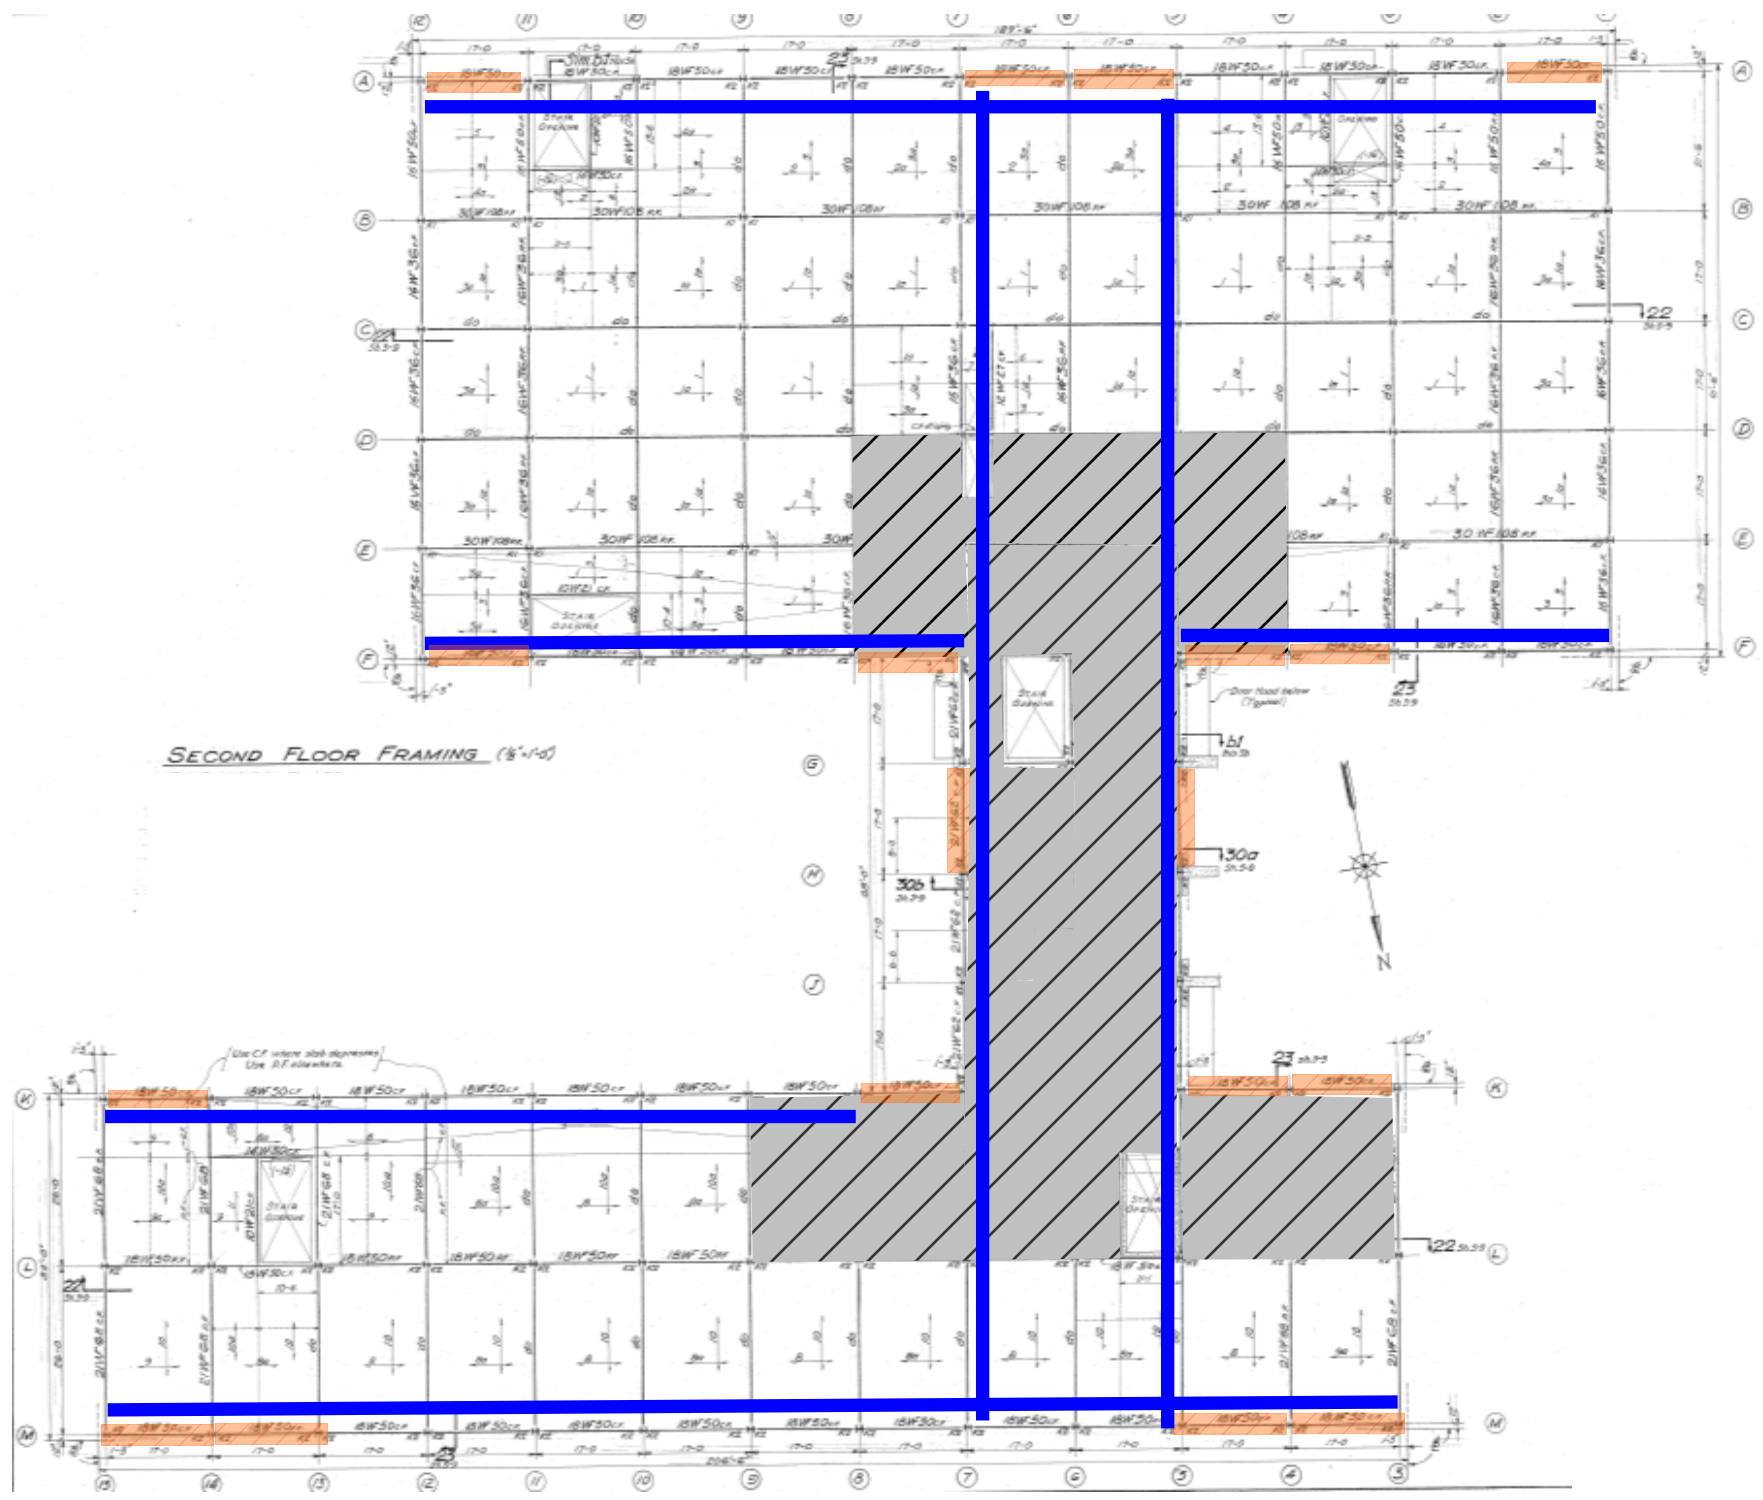
Job: Judicial Council	Job #: 259713
Title: 07-F1 George D. Carroll Courthouse Seismic retrofit scheme	
Prepared By: SF	Page: S4
Sketch #: Second floor plan	ARUP
Date: 2018-05-25	
Scale: NTS Original paper size: 11" x 17"

Add buckling-restrained brace (BRBF) in single diagonal pattern

4	The diaphragm bridging between the two building wings lack shear capacity and collectors to transfer the loads between the two building wings	Install BRB's on two sides of the bridge along transverse (NS) direction (single diagonal pattern, from above First floor to under roof for two stories), and strengthen the diaphragm with bi-directional FRP overlays for shear strengthening and uni-directional FRP overlays for collector strengthening.
5	The roof diaphragm above courtrooms with a large opening is deficient for shear transfer and its collectors needs strengthening.	Strengthen the diaphragm with bi-directional FRP overlays for shear strengthening and uni-directional FRP overlays for collector strengthening.
6	Cladding over six entrance doors including brick veneers, porcelain enamel panels, and sun shades lack sufficient connections to the structure and pose life-safety risks over egress paths.	Replace heavy cladding with façade that can undertake anticipated level of drift. This applies only to about 3,000 SF above six entrance doors.

7	Egress stairs not sufficiently detailed to accommodate drift	Limit drift by adding buckling-restrained braces (see description of item 1)

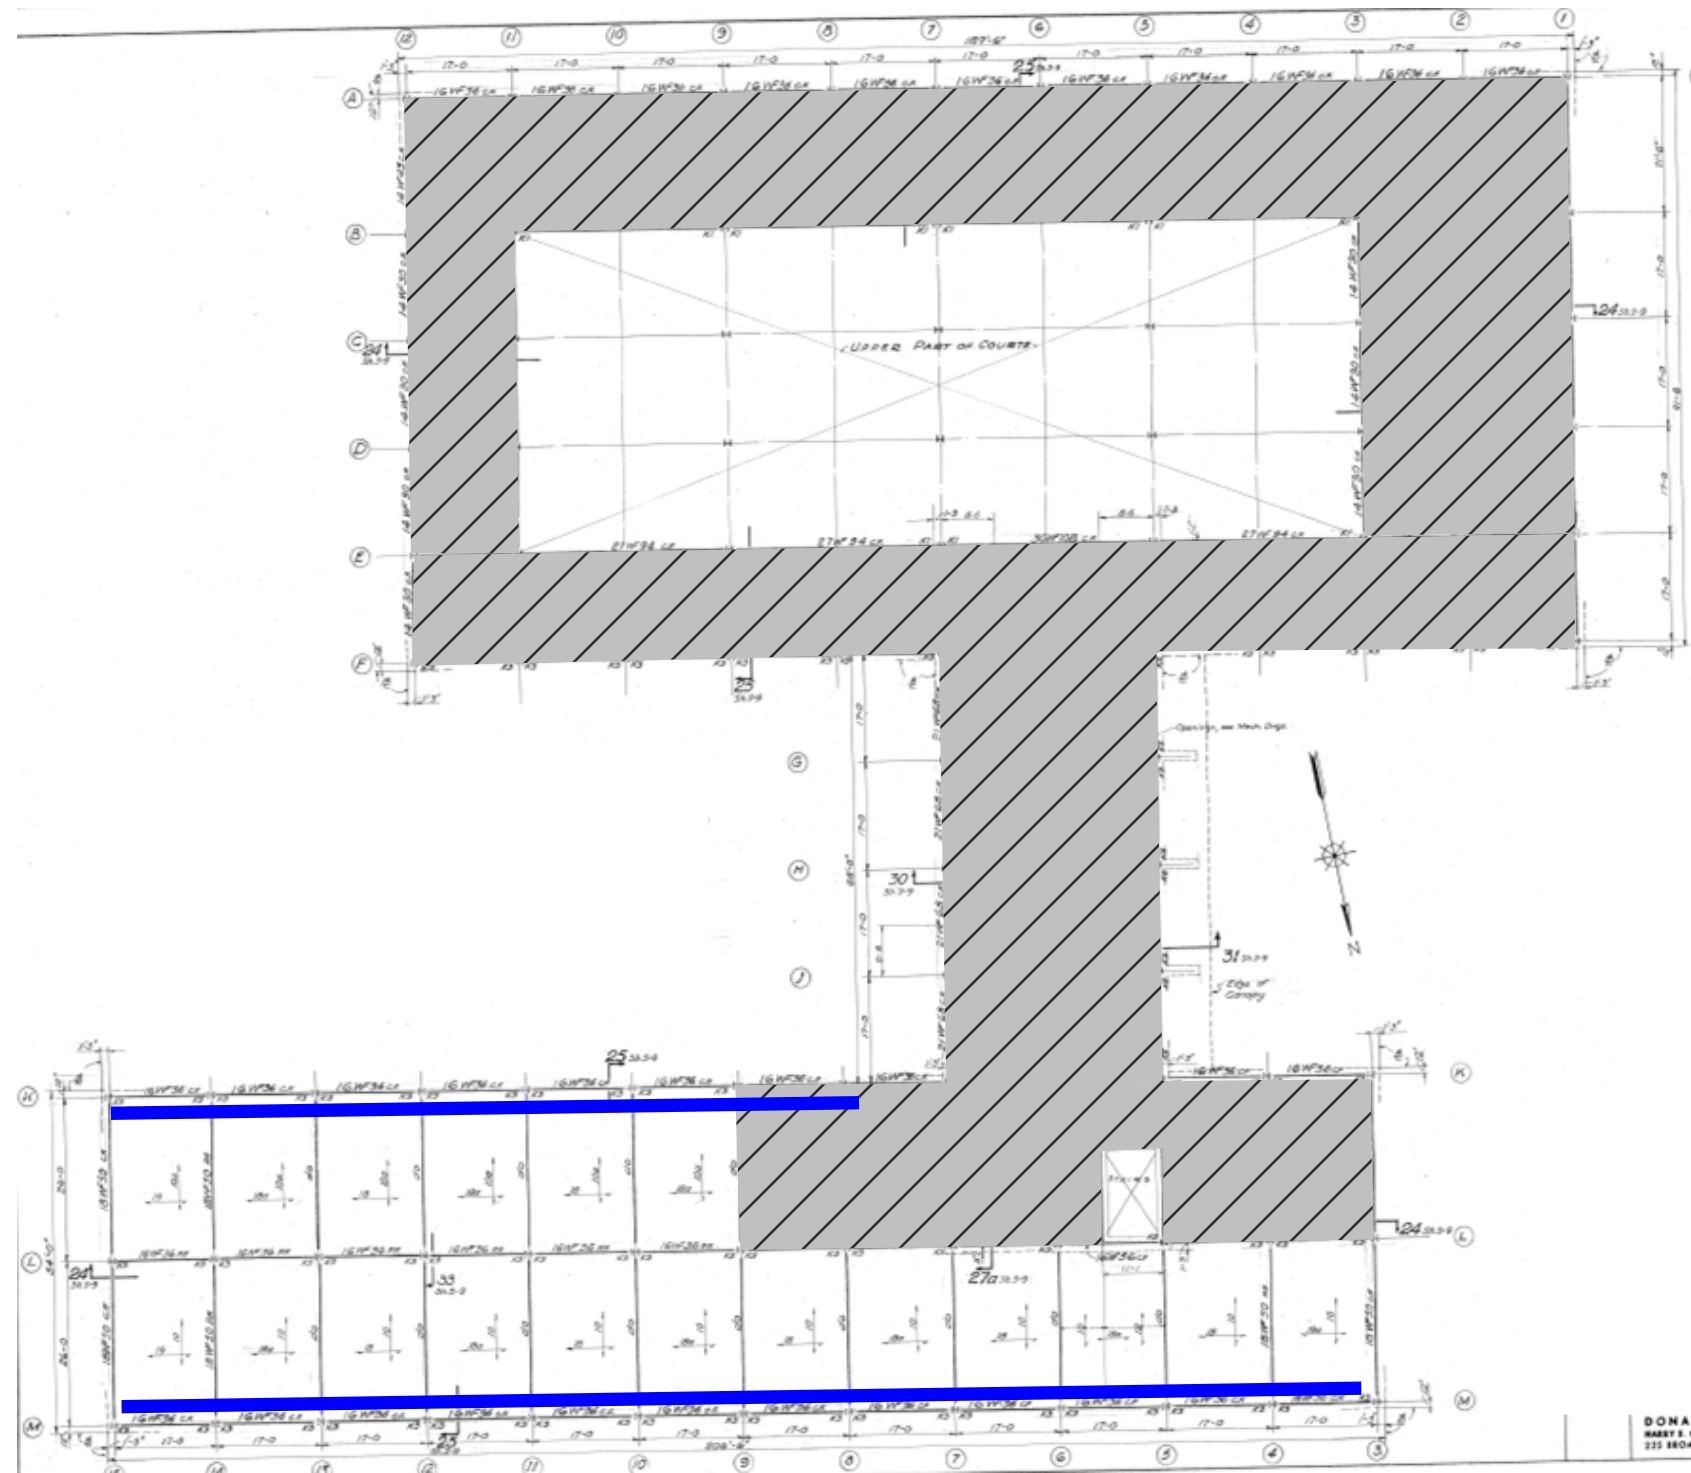
Add buckling-restrained brace (BRBF) in single diagonal pattern

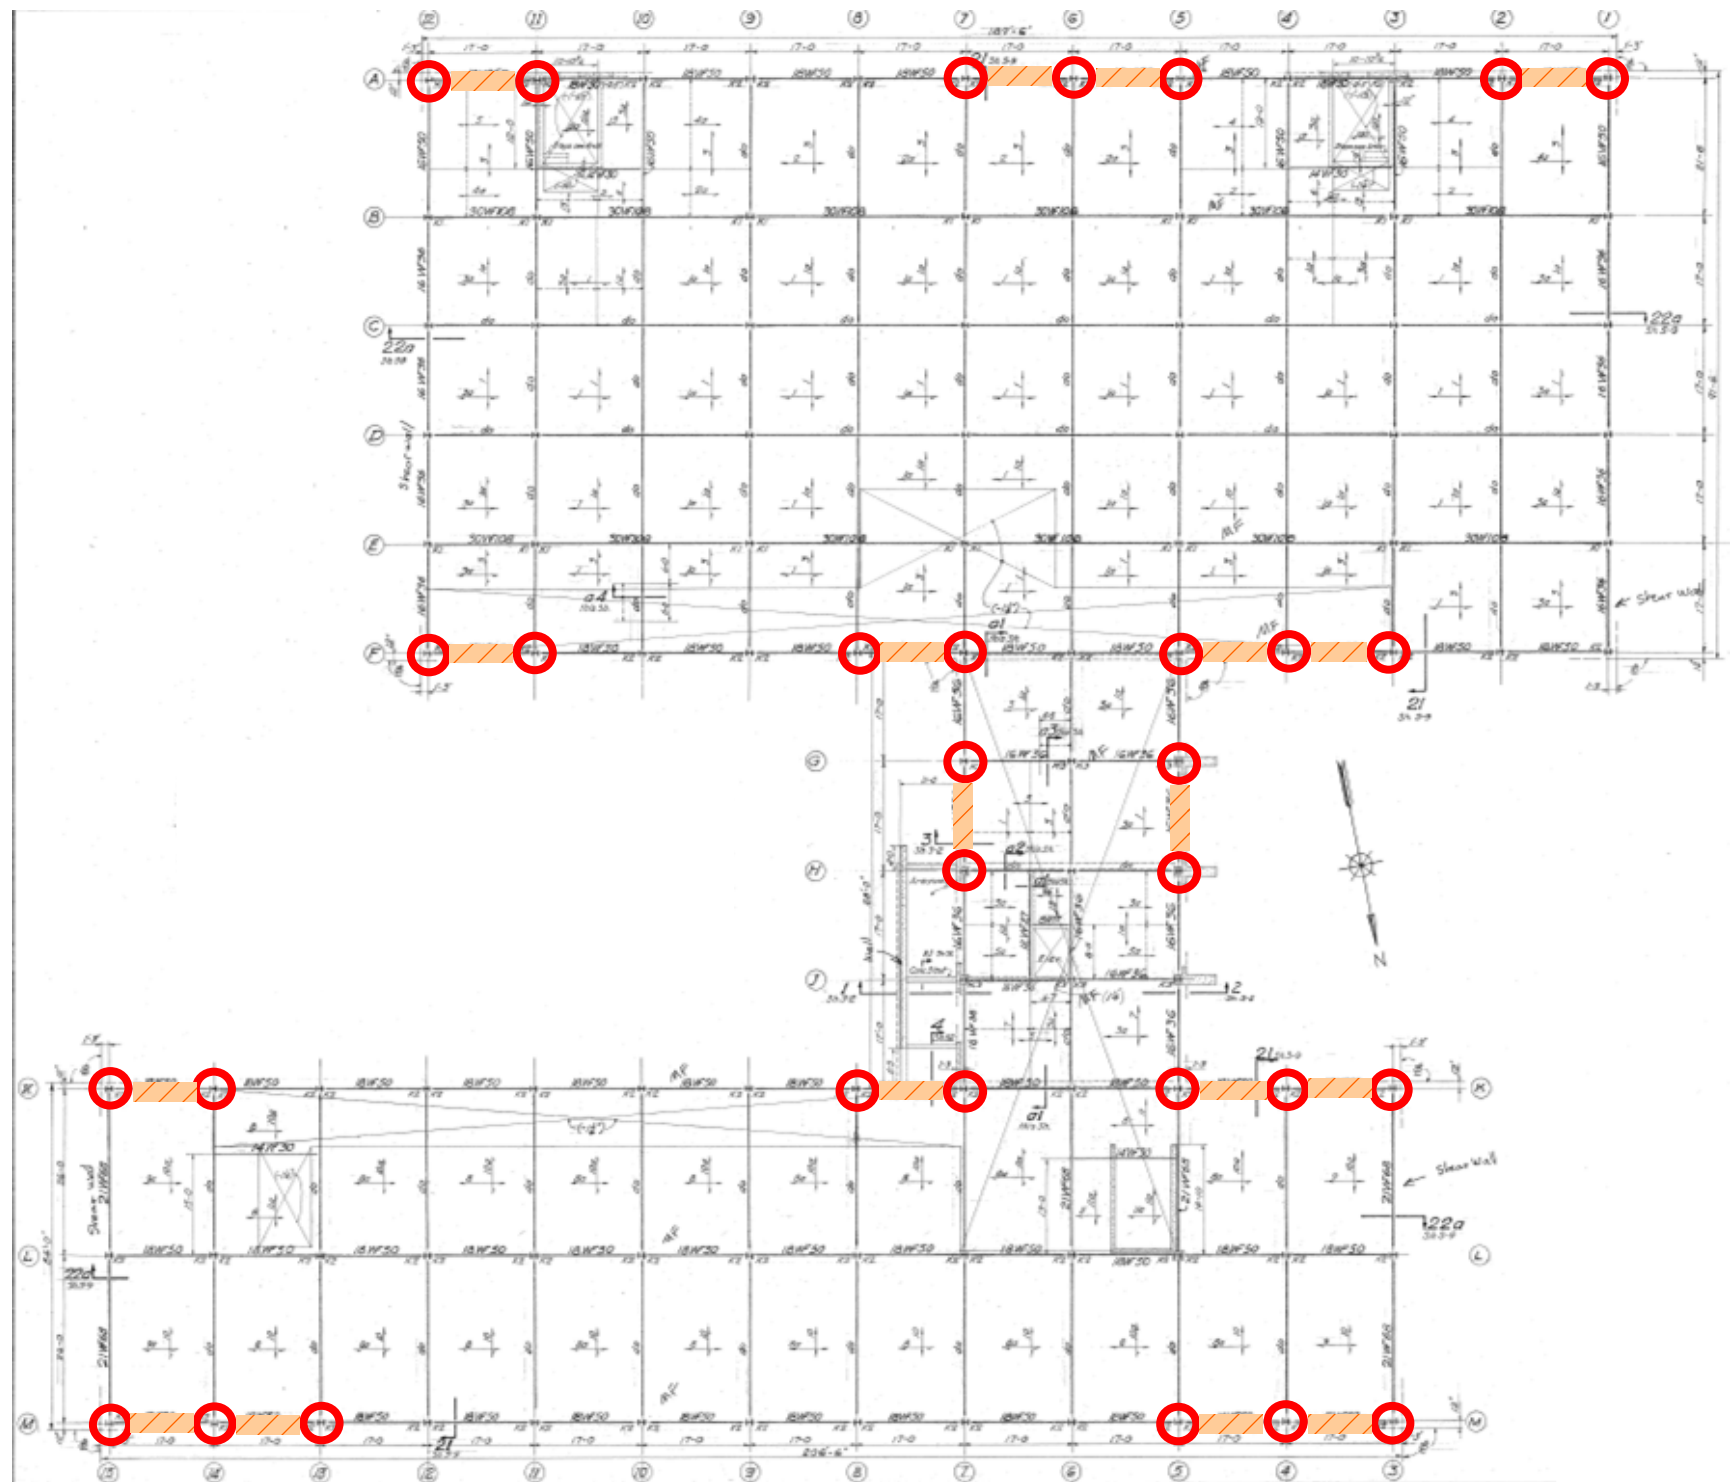
Job: Judicial Council	Job #: 259713
Title: 07-F1 George D. Carroll Courthouse Seismic retrofit scheme	
Prepared By: SF	Page: S6
Sketch #: All floors	
Date: 2018-05-25	
Scale: NTS	
Original paper size: 11" x 17"	
ARUP

Add cover plates to strengthen columns connected to BRB's from above First Floor to under Roof

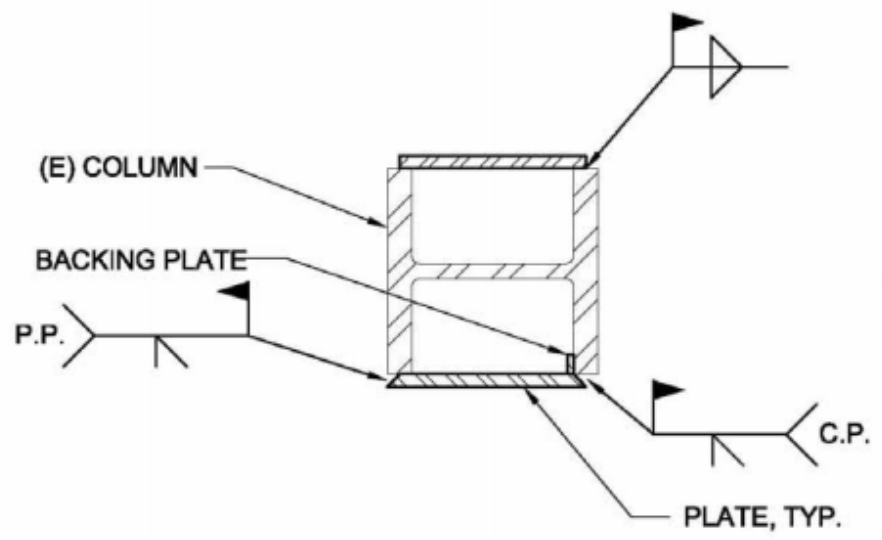
Figure 8.4.3-2: Box Section at Existing Column

Note:
Welds shown indicate alternate possibilities of plate attachment.

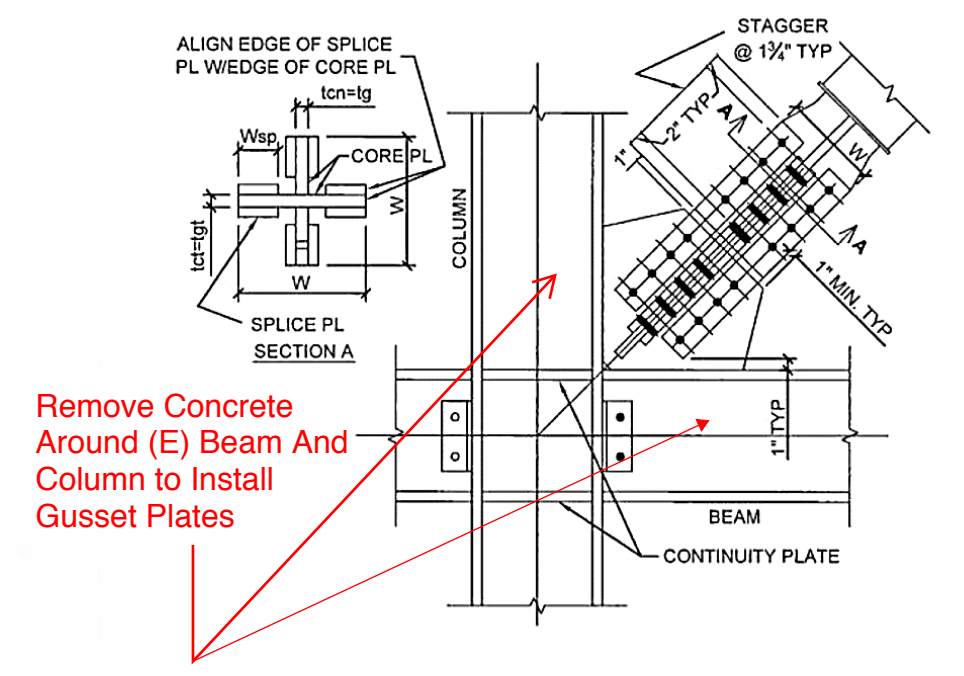
DETAIL 5: Strengthen Existing Column

Remove Concrete Around (E) Beam And Column to Install Gusset Plates

BRBF CONNECTION DETAIL DETAIL BY COREBRACE
